CITY OF SAN MARCOS ADA TRANSITION PLAN SIGNALIZED INTERSECTION ASSESSMENT AND COMPLIANCE REPORT

Location ID: 0000000145
 North-South Cross Street: UNIVERSITY DR
 East-West Cross Street: CM ALLEN PKWY

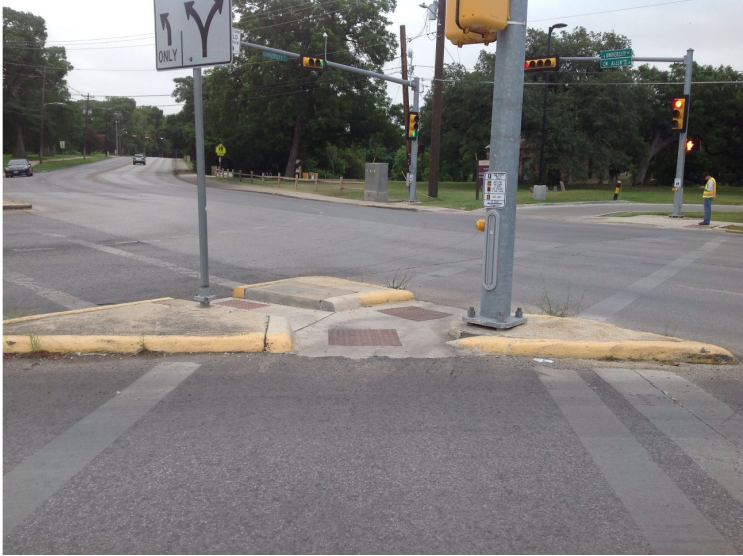
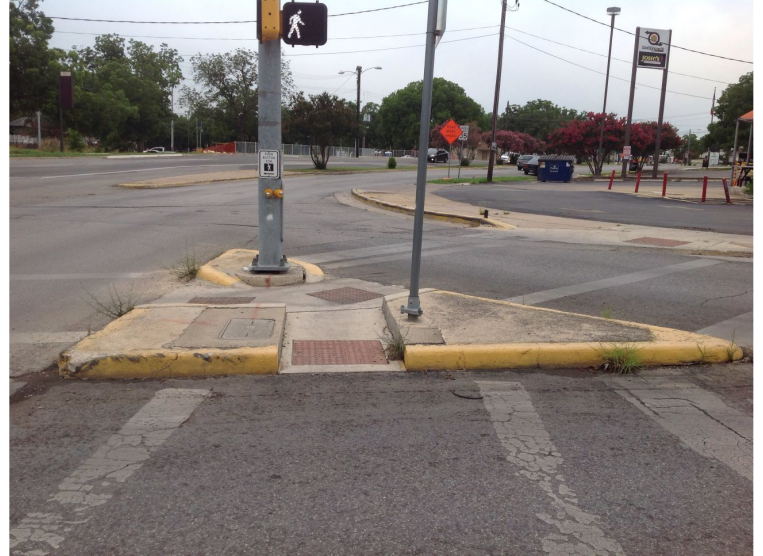
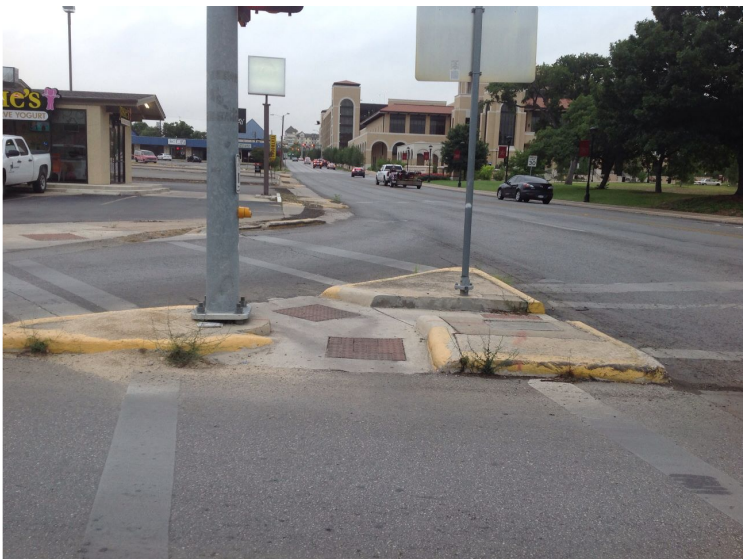
Location Photos

Ramp Elements	Curb ramp provided where an accessible route crosses a barrier:	YES
	Is the slope of the ramp 1:12 or less:	YES
	Transition from curb ramp slope to roadway free from abrupt changes, no greater than 1:20:	YES
	Ramp is at least 36" wide:	YES
	Ramp surface is stable, firm, and slip resistant:	YES
Flare	Flares (if present) are 1:10 or less measured along the curb line; or If landing at top of ramp is not provided flares are 1:12 or less:	NO
Detectable Warning Surface	Curb ramp is located such that it does not project into roadway or parking aisles:	N/A
	Detectable warning is present:	NO
	DWS maintains correct geometric controls; 0.9" diameter domes, 0.2" in height, spaced at 2.35" and visually contrasts adjacent ramp surface:	YES
Special Ramps	Ramp maintains defined edges parallel to direction of pedestrian travel; maintains 4'x4' turning pad contained in crosswalk; flared sides 24" segment on each side of ramp within crosswalk lines:	N/A

Ramp is located so they will not be obstructed by parked vehicles:	N/A
	Ramp wholly contained within the crosswalk lines:	YES
	If island is present; Island maintains a cut through at street level or ramps on either side with landing between them:	YES
