**CITY OF SAN MARCOS
ADA TRANSITION PLAN
SIGNALIZED INTERSECTION ASSESSMENT
AND COMPLIANCE REPORT**

Location ID: 0000000147
 North-South Cross Street: C M ALLEN PKWY
 East-West Cross Street: SESSOM DR

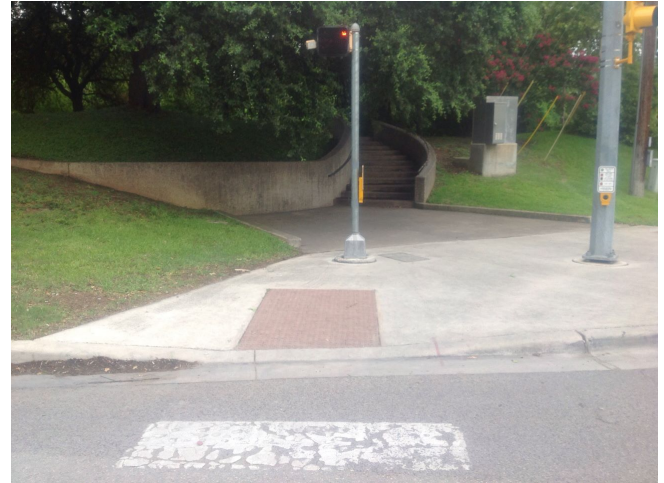
Ramp Elements	Curb ramp provided where an accessible route crosses a barrier:	YES
	Is the slope of the ramp 1:12 or less:	NO
	Transition from curb ramp slope to roadway free from abrupt changes, no greater than 1:20:	YES
	Ramp is at least 36" wide:	YES
	Ramp surface is stable, firm, and slip resistant:	YES
Flare	Flares (if present) are 1:10 or less measured along the curb line; or If landing at top of ramp is not provided flares are 1:12 or less:	YES
Detectable Warning Surface	Curb ramp is located such that it does not project into roadway or parking aisles:	N/A
	Detectable warning is present:	YES
	DWS maintains correct geometric controls; 0.9" diameter domes, 0.2" in height, spaced at 2.35" and visually contracts adjacent ramp surface:	YES
Special Ramps	Ramp maintains defined edges parallel to direction of pedestrian travel; maintains 4'x4' turning pad contained in crosswalk; flared sides 24" segment on each side of ramp within crosswalk lines:	N/A

Ramp is located so they will not be obstructed by parked vehicles:	N/A
	Ramp wholly contained within the crosswalk lines:	YES
	If island is present; Island maintains a cut through at street level or ramps on either side with landing between them:	N/A
