**CITY OF SAN MARCOS
ADA TRANSITION PLAN
SIGNALIZED INTERSECTION ASSESSMENT
AND COMPLIANCE REPORT**

Location ID: 0000000148
 North-South Cross Street: C M ALLEN PKWY
 East-West Cross Street: SESSOM DR

North-South Cross Street: C M ALLEN PKWY

East-West Cross Street: SESSOM DR

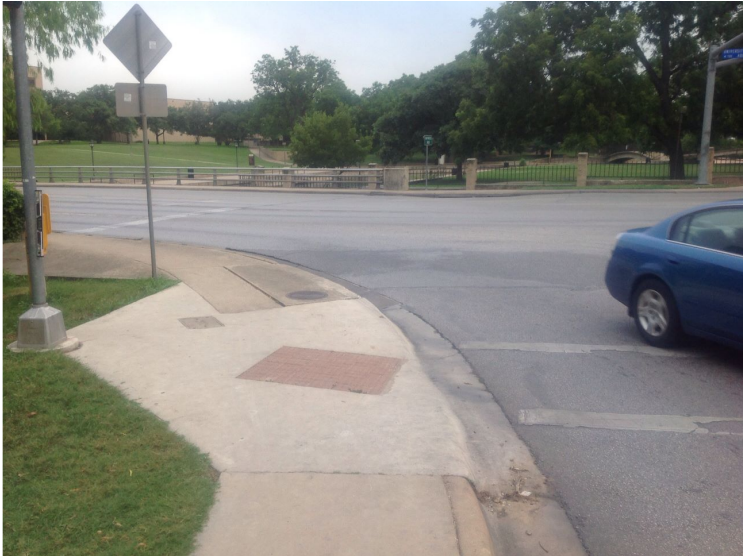
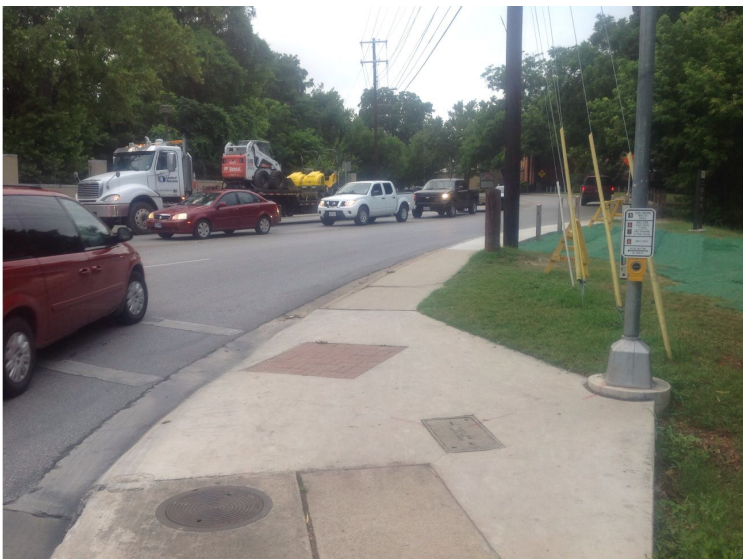
Location Photos

Ramp Elements	Curb ramp provided where an accessible route crosses a barrier:	YES
	Is the slope of the ramp 1:12 or less:	NO
	Transition from curb ramp slope to roadway free from abrupt changes, no greater than 1:20:	YES
	Ramp is at least 36" wide:	YES
	Ramp surface is stable, firm, and slip resistant:	YES
Flare	Flares (if present) are 1:10 or less measured along the curb line; or If landing at top of ramp is not provided flares are 1:12 or less:	YES
Detectable Warning Surface	Curb ramp is located such that it does not project into roadway or parking aisles:	N/A
	Detectable warning is present:	NO
	DWS maintains correct geometric controls; 0.9" diameter domes, 0.2" in height, spaced at 2.35" and visually contracts adjacent ramp surface:	YES
Special Ramps	Ramp maintains defined edges parallel to direction of pedestrian travel; maintains 4'x4' turning pad contained in crosswalk; flared sides 24" segment on each side of ramp within crosswalk lines:	N/A
