**CITY OF SAN MARCOS  
ADA TRANSITION PLAN  
SIGNALIZED INTERSECTION ASSESSMENT  
AND COMPLIANCE REPORT**

Location ID: 0000000150  
 North-South Cross Street: SESSOM DR  
 East-West Cross Street: PEQUES ST

North-South Cross Street: SESSOM DR

East-West Cross Street: PEQUES ST

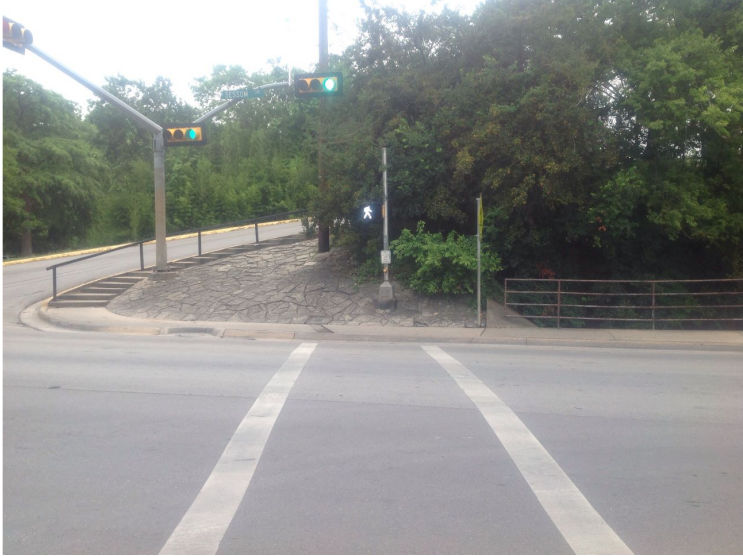
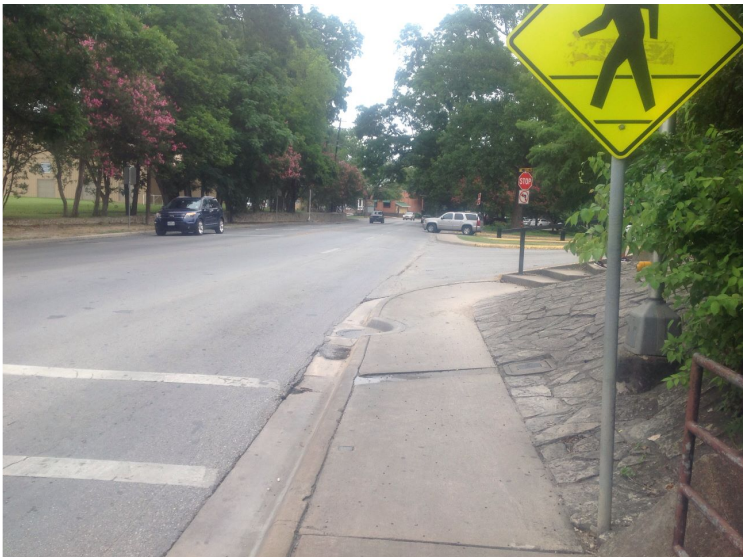
## Location Photos

<b>Ramp Elements</b>	Curb ramp provided where an accessible route crosses a barrier:	NO
	Is the slope of the ramp 1:12 or less:	NO
	Transition from curb ramp slope to roadway free from abrupt changes, no greater than 1:20:	NO
	Ramp is at least 36" wide:	NO
	Ramp surface is stable, firm, and slip resistant:	NO
<b>Flare</b>	Flares (if present) are 1:10 or less measured along the curb line; or If landing at top of ramp is not provided flares are 1:12 or less:	NO
<b>Detectable Warning Surface</b>	Curb ramp is located such that it does not project into roadway or parking aisles:	N/A
	Detectable warning is present:	NO
	DWS maintains correct geometric controls; 0.9" diameter domes, 0.2" in height, spaced at 2.35" and visually contracts adjacent ramp surface:	NO
<b>Special Ramps</b>	Ramp maintains defined edges parallel to direction of pedestrian travel; maintains 4'x4' turning pad contained in crosswalk; flared sides 24" segment on each side of ramp within crosswalk lines:	N/A
