CITY OF SAN MARCOS ADA TRANSITION PLAN SIGNALIZED INTERSECTION ASSESSMENT AND COMPLIANCE REPORT

Location ID: 0000000156
 North-South Cross Street: HOPKINS DR
 East-West Cross Street: CHARLES AUSTIN DR

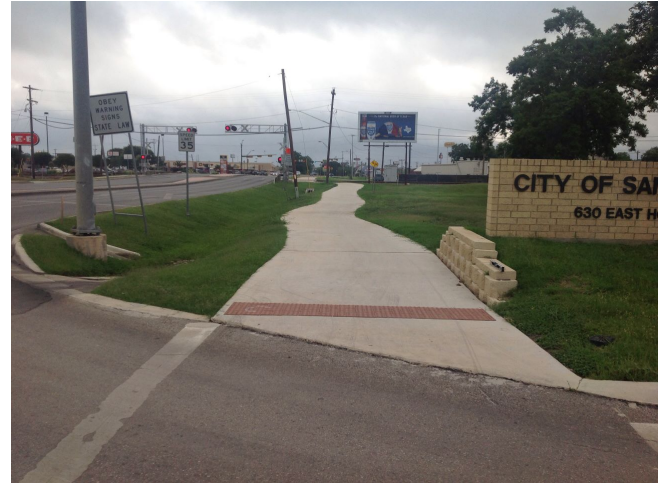
Signalized Intersection: YES
 Accessible Features: NO
 Pedestrian Features Accessible: NO

Ramp Elements	Curb ramp provided where an accessible route crosses a barrier:	NO
	Is the slope of the ramp 1:12 or less:	YES
	Transition from curb ramp slope to roadway free from abrupt changes, no greater than 1:20:	NO
	Ramp is at least 36" wide:	YES
	Ramp surface is stable, firm, and slip resistant:	YES
Flare	Flares (if present) are 1:10 or less measured along the curb line; or If landing at top of ramp is not provided flares are 1:12 or less:	N/A
Detectable Warning Surface	Curb ramp is located such that it does not project into roadway or parking aisles:	N/A
	Detectable warning is present:	YES
	DWS maintains correct geometric controls; 0.9" diameter domes, 0.2" in height, spaced at 2.35" and visually contrasts adjacent ramp surface:	YES
Special Ramps	Ramp maintains defined edges parallel to direction of pedestrian travel; maintains 4'x4' turning pad contained in crosswalk; flared sides 24" segment on each side of ramp within crosswalk lines:	N/A

Ramp is located so they will not be obstructed by parked vehicles:	N/A
	Ramp wholly contained within the crosswalk lines:	YES
	If island is present; Island maintains a cut through at street level or ramps on either side with landing between them:	N/A
