**CITY OF SAN MARCOS  
ADA TRANSITION PLAN  
SIGNALIZED INTERSECTION ASSESSMENT  
AND COMPLIANCE REPORT**

Location ID: 0000000157  
 North-South Cross Street: HOPKINS DR  
 East-West Cross Street: CHARLES AUSTIN DR

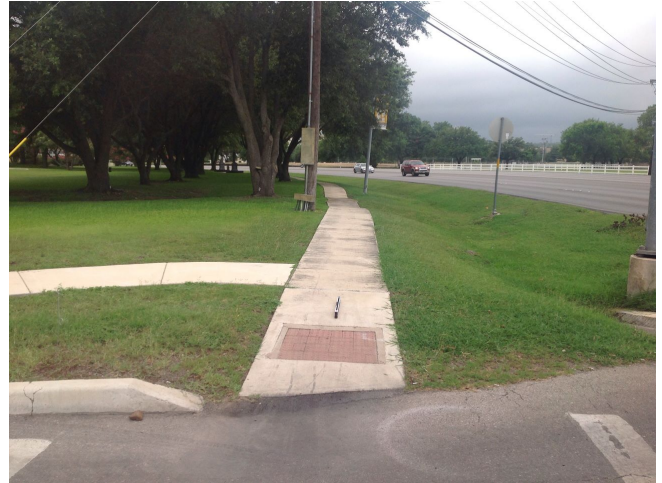
Signalized Intersection: YES  
 Accessible Features: NO  
 Pedestrian Features Accessible: NO

<b>Ramp Elements</b>	Curb ramp provided where an accessible route crosses a barrier:	NO
	Is the slope of the ramp 1:12 or less:	NO
	Transition from curb ramp slope to roadway free from abrupt changes, no greater than 1:20:	YES
	Ramp is at least 36" wide:	YES
	Ramp surface is stable, firm, and slip resistant:	YES
<b>Flare</b>	Flares (if present) are 1:10 or less measured along the curb line; or If landing at top of ramp is not provided flares are 1:12 or less:	N/A
<b>Detectable Warning Surface</b>	Curb ramp is located such that it does not project into roadway or parking aisles:	N/A
	Detectable warning is present:	NO
	DWS maintains correct geometric controls; 0.9" diameter domes, 0.2" in height, spaced at 2.35" and visually contrasts adjacent ramp surface:	YES
<b>Special Ramps</b>	Ramp maintains defined edges parallel to direction of pedestrian travel; maintains 4'x4' turning pad contained in crosswalk; flared sides 24" segment on each side of ramp within crosswalk lines:	N/A

Ramp is located so they will not be obstructed by parked vehicles:	N/A
	Ramp wholly contained within the crosswalk lines:	YES
	If island is present; Island maintains a cut through at street level or ramps on either side with landing between them:	N/A
