# CITY OF SAN MARCOS ADA TRANSITION PLAN SIGNALIZED INTERSECTION ASSESSMENT AND COMPLIANCE REPORT

Location ID: 0000000160  
 North-South Cross Street: THORPE LN  
 East-West Cross Street: HOPKINS ST

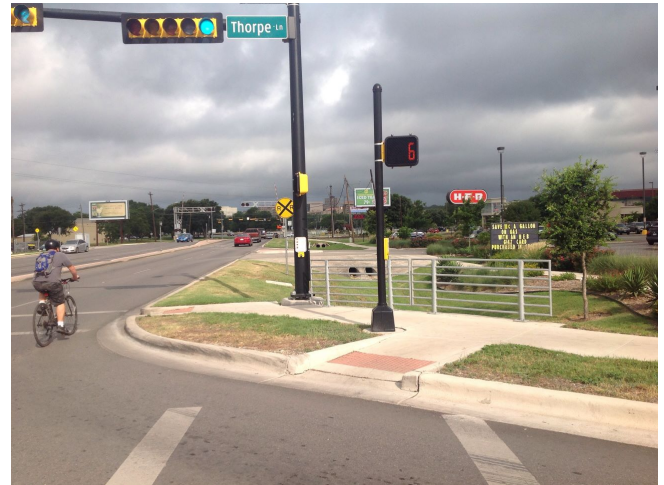
Signalized Intersection: YES  
 Accessible Features: YES  
 Pedestrian Features Accessible: YES

<b>Ramp Elements</b>	Curb ramp provided where an accessible route crosses a barrier:	YES
	Is the slope of the ramp 1:12 or less:	YES
	Transition from curb ramp slope to roadway free from abrupt changes, no greater than 1:20:	YES
	Ramp is at least 36" wide:	YES
	Ramp surface is stable, firm, and slip resistant:	YES
<b>Flare</b>	Flares (if present) are 1:10 or less measured along the curb line; or If landing at top of ramp is not provided flares are 1:12 or less:	N/A
<b>Detectable Warning Surface</b>	Curb ramp is located such that it does not project into roadway or parking aisles:	N/A
	Detectable warning is present:	YES
	DWS maintains correct geometric controls; 0.9" diameter domes, 0.2" in height, spaced at 2.35" and visually contracts adjacent ramp surface:	YES
<b>Special Ramps</b>	Ramp maintains defined edges parallel to direction of pedestrian travel; maintains 4'x4' turning pad contained in crosswalk; flared sides 24" segment on each side of ramp within crosswalk lines:	N/A

Ramp is located so they will not be obstructed by parked vehicles:	N/A
	Ramp wholly contained within the crosswalk lines:	YES
	If island is present; Island maintains a cut through at street level or ramps on either side with landing between them:	YES
