**CITY OF SAN MARCOS
ADA TRANSITION PLAN
SIGNALIZED INTERSECTION ASSESSMENT
AND COMPLIANCE REPORT**

Location ID: 0000000165
 North-South Cross Street: THORPE LN
 East-West Cross Street: POST RD

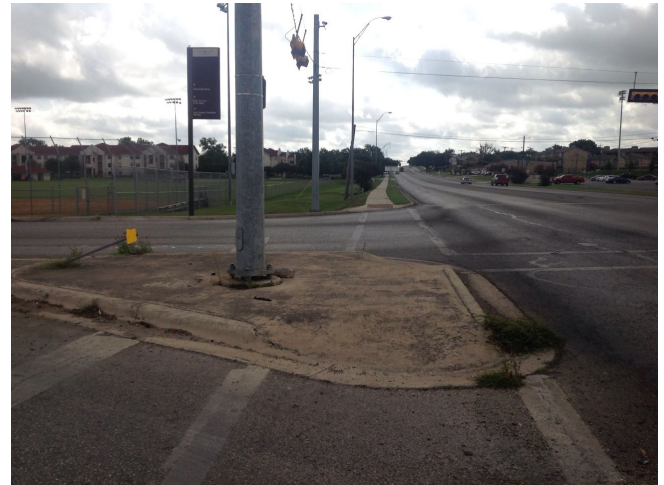
Ramp Elements	Curb ramp provided where an accessible route crosses a barrier:	YES
	Is the slope of the ramp 1:12 or less:	NO
	Transition from curb ramp slope to roadway free from abrupt changes, no greater than 1:20:	YES
	Ramp is at least 36" wide:	YES
	Ramp surface is stable, firm, and slip resistant:	YES
Flare	Flares (if present) are 1:10 or less measured along the curb line; or If landing at top of ramp is not provided flares are 1:12 or less:	NO
Detectable Warning Surface	Curb ramp is located such that it does not project into roadway or parking aisles:	N/A
	Detectable warning is present:	NO
	DWS maintains correct geometric controls; 0.9" diameter domes, 0.2" in height, spaced at 2.35" and visually contrasts adjacent ramp surface:	NO
Special Ramps	Ramp maintains defined edges parallel to direction of pedestrian travel; maintains 4'x4' turning pad contained in crosswalk; flared sides 24" segment on each side of ramp within crosswalk lines:	YES

Ramp is located so they will not be obstructed by parked vehicles:	N/A
	Ramp wholly contained within the crosswalk lines:	YES
	If island is present; Island maintains a cut through at street level or ramps on either side with landing between them:	YES
