**CITY OF SAN MARCOS
ADA TRANSITION PLAN
SIGNALIZED INTERSECTION ASSESSMENT
AND COMPLIANCE REPORT**

Location ID: 0000000166
 North-South Cross Street: THORPE LN
 East-West Cross Street: POST RD

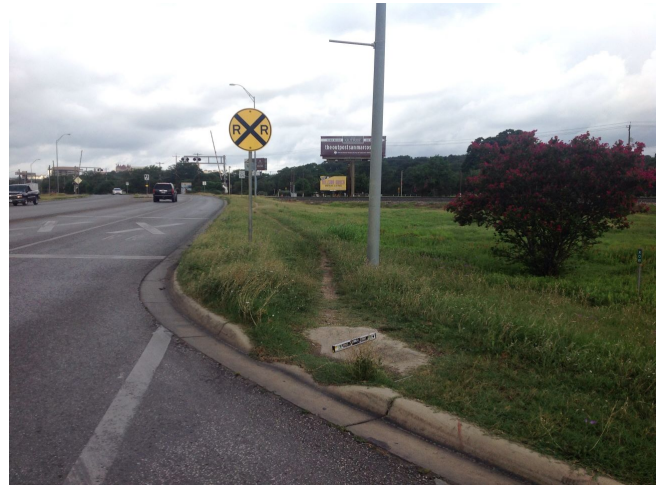
Ramp Elements	Curb ramp provided where an accessible route crosses a barrier:	YES
	Is the slope of the ramp 1:12 or less:	YES
	Transition from curb ramp slope to roadway free from abrupt changes, no greater than 1:20:	NO
	Ramp is at least 36" wide:	YES
	Ramp surface is stable, firm, and slip resistant:	YES
Flare	Flares (if present) are 1:10 or less measured along the curb line; or If landing at top of ramp is not provided flares are 1:12 or less:	NO
Detectable Warning Surface	Curb ramp is located such that it does not project into roadway or parking aisles:	N/A
	Detectable warning is present:	NO
	DWS maintains correct geometric controls; 0.9" diameter domes, 0.2" in height, spaced at 2.35" and visually contracts adjacent ramp surface:	NO
Special Ramps	Ramp maintains defined edges parallel to direction of pedestrian travel; maintains 4'x4' turning pad contained in crosswalk; flared sides 24" segment on each side of ramp within crosswalk lines:	N/A

Ramp is located so they will not be obstructed by parked vehicles:	N/A
	Ramp wholly contained within the crosswalk lines:	YES
	If island is present; Island maintains a cut through at street level or ramps on either side with landing between them:	YES
