CITY OF SAN MARCOS ADA TRANSITION PLAN SIGNALIZED INTERSECTION ASSESSMENT AND COMPLIANCE REPORT

Location ID: 0000000174
 North-South Cross Street: IH 35 SBFR
 East-West Cross Street: AQUARENA SPRINGS DR

Location ID: 0000000174

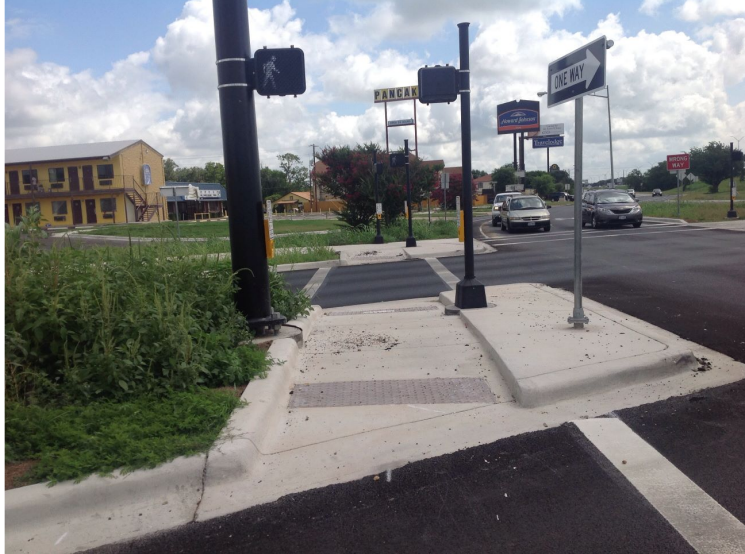
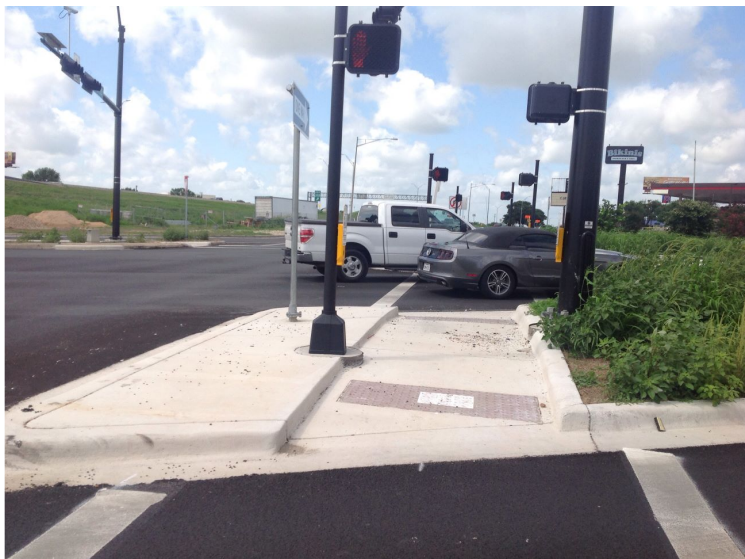
Location Photos

Ramp Elements	Curb ramp provided where an accessible route crosses a barrier:	YES
	Is the slope of the ramp 1:12 or less:	YES
	Transition from curb ramp slope to roadway free from abrupt changes, no greater than 1:20:	YES
	Ramp is at least 36" wide:	YES
	Ramp surface is stable, firm, and slip resistant:	YES
Flare	Flares (if present) are 1:10 or less measured along the curb line; or If landing at top of ramp is not provided flares are 1:12 or less:	N/A
Detectable Warning Surface	Curb ramp is located such that it does not project into roadway or parking aisles:	N/A
	Detectable warning is present:	YES
	DWS maintains correct geometric controls; 0.9" diameter domes, 0.2" in height, spaced at 2.35" and visually contrasts adjacent ramp surface:	YES
Special Ramps	Ramp maintains defined edges parallel to direction of pedestrian travel; maintains 4'x4' turning pad contained in crosswalk; flared sides 24" segment on each side of ramp within crosswalk lines:	N/A

Ramp is located so they will not be obstructed by parked vehicles:	N/A
	Ramp wholly contained within the crosswalk lines:	YES
	If island is present; Island maintains a cut through at street level or ramps on either side with landing between them:	YES
