**CITY OF SAN MARCOS
ADA TRANSITION PLAN
SIGNALIZED INTERSECTION ASSESSMENT
AND COMPLIANCE REPORT**

Location ID: 0000000190
 North-South Cross Street: CLAREWOOD DR
 East-West Cross Street: TX HWY 80

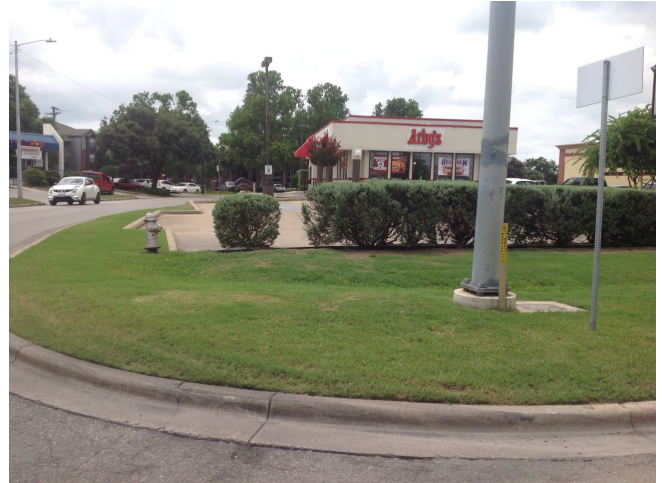
Signalized Intersection: YES
 Accessible Features: NO
 Pedestrian Features Accessible: NO

Ramp Elements	Curb ramp provided where an accessible route crosses a barrier:	NO
	Is the slope of the ramp 1:12 or less:	NO
	Transition from curb ramp slope to roadway free from abrupt changes, no greater than 1:20:	NO
	Ramp is at least 36" wide:	NO
	Ramp surface is stable, firm, and slip resistant:	NO
Flare	Flares (if present) are 1:10 or less measured along the curb line; or If landing at top of ramp is not provided flares are 1:12 or less:	NO
Detectable Warning Surface	Curb ramp is located such that it does not project into roadway or parking aisles:	N/A
	Detectable warning is present:	NO
	DWS maintains correct geometric controls; 0.9" diameter domes, 0.2" in height, spaced at 2.35" and visually contracts adjacent ramp surface:	NO
Special Ramps	Ramp maintains defined edges parallel to direction of pedestrian travel; maintains 4'x4' turning pad contained in crosswalk; flared sides 24" segment on each side of ramp within crosswalk lines:	N/A
