CITY OF SAN MARCOS ADA TRANSITION PLAN SIGNALIZED INTERSECTION ASSESSMENT AND COMPLIANCE REPORT

Location ID: 0000000192
 North-South Cross Street: RIVER RD
 East-West Cross Street: TX HWY 80

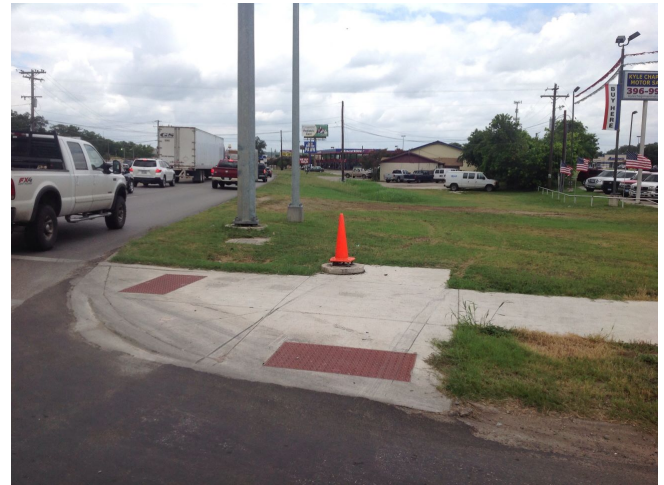
Signalized Intersection: YES
 Accessible Features: NO
 Pedestrian Features Accessible: NO

Ramp Elements	Curb ramp provided where an accessible route crosses a barrier:	YES
	Is the slope of the ramp 1:12 or less:	YES
	Transition from curb ramp slope to roadway free from abrupt changes, no greater than 1:20:	YES
	Ramp is at least 36" wide:	YES
	Ramp surface is stable, firm, and slip resistant:	YES
Flare	Flares (if present) are 1:10 or less measured along the curb line; or If landing at top of ramp is not provided flares are 1:12 or less:	YES
Detectable Warning Surface	Curb ramp is located such that it does not project into roadway or parking aisles:	N/A
	Detectable warning is present:	YES
	DWS maintains correct geometric controls; 0.9" diameter domes, 0.2" in height, spaced at 2.35" and visually contrasts adjacent ramp surface:	YES
Special Ramps	Ramp maintains defined edges parallel to direction of pedestrian travel; maintains 4'x4' turning pad contained in crosswalk; flared sides 24" segment on each side of ramp within crosswalk lines:	N/A

Ramp is located so they will not be obstructed by parked vehicles:	YES
	Ramp wholly contained within the crosswalk lines:	YES
	If island is present; Island maintains a cut through at street level or ramps on either side with landing between them:	N/A
