# CITY OF SAN MARCOS ADA TRANSITION PLAN SIGNALIZED INTERSECTION ASSESSMENT AND COMPLIANCE REPORT

Location ID: 0000000194  
 North-South Cross Street: IH 35 SBFR  
 East-West Cross Street: CENTERPOINT RD

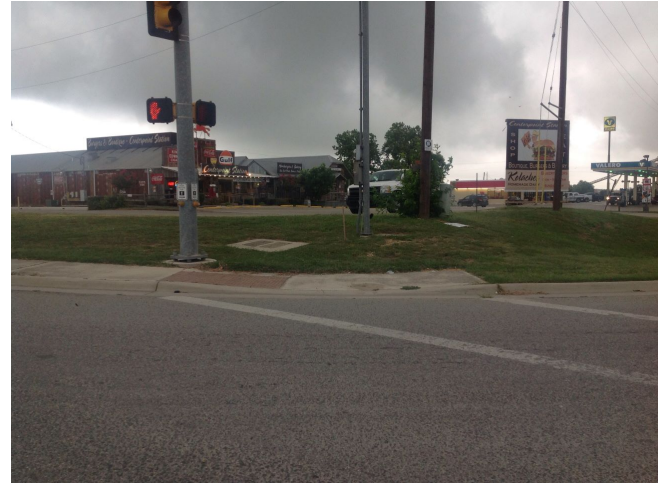
Signalized Intersection: YES  
 Accessible Features: YES  
 Pedestrian Features Accessible: NO

<b>Ramp Elements</b>	Curb ramp provided where an accessible route crosses a barrier:	YES
	Is the slope of the ramp 1:12 or less:	YES
	Transition from curb ramp slope to roadway free from abrupt changes, no greater than 1:20:	YES
	Ramp is at least 36" wide:	YES
	Ramp surface is stable, firm, and slip resistant:	YES
<b>Flare</b>	Flares (if present) are 1:10 or less measured along the curb line; or If landing at top of ramp is not provided flares are 1:12 or less:	NO
<b>Detectable Warning Surface</b>	Curb ramp is located such that it does not project into roadway or parking aisles:	N/A
	Detectable warning is present:	YES
	DWS maintains correct geometric controls; 0.9" diameter domes, 0.2" in height, spaced at 2.35" and visually contracts adjacent ramp surface:	YES
<b>Special Ramps</b>	Ramp maintains defined edges parallel to direction of pedestrian travel; maintains 4'x4' turning pad contained in crosswalk; flared sides 24" segment on each side of ramp within crosswalk lines:	N/A

Ramp is located so they will not be obstructed by parked vehicles:	N/A
	Ramp wholly contained within the crosswalk lines:	NO
	If island is present; Island maintains a cut through at street level or ramps on either side with landing between them:	N/A
