**CITY OF SAN MARCOS  
ADA TRANSITION PLAN  
SIGNALIZED INTERSECTION ASSESSMENT  
AND COMPLIANCE REPORT**

Location ID: 000000206  
 North-South Cross Street: SH 123  
 East-West Cross Street: DE ZAVALA DR

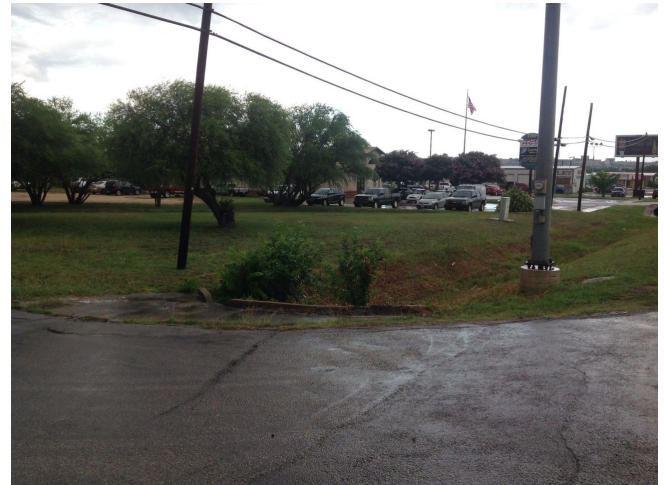
Signalized Intersection: YES  
 Accessible Features: NO  
 Pedestrian Features Accessible: NO

<b>Ramp Elements</b>	Curb ramp provided where an accessible route crosses a barrier:	NO
	Is the slope of the ramp 1:12 or less:	NO
	Transition from curb ramp slope to roadway free from abrupt changes, no greater than 1:20:	NO
	Ramp is at least 36" wide:	NO
	Ramp surface is stable, firm, and slip resistant:	NO
<b>Flare</b>	Flares (if present) are 1:10 or less measured along the curb line; or If landing at top of ramp is not provided flares are 1:12 or less:	NO
<b>Detectable Warning Surface</b>	Curb ramp is located such that it does not project into roadway or parking aisles:	N/A
	Detectable warning is present:	NO
	DWS maintains correct geometric controls; 0.9" diameter domes, 0.2" in height, spaced at 2.35" and visually contracts adjacent ramp surface:	NO
<b>Special Ramps</b>	Ramp maintains defined edges parallel to direction of pedestrian travel; maintains 4'x4' turning pad contained in crosswalk; flared sides 24" segment on each side of ramp within crosswalk lines:	N/A
