# CITY OF SAN MARCOS ADA TRANSITION PLAN SIGNALIZED INTERSECTION ASSESSMENT AND COMPLIANCE REPORT

Location ID: 000000207  
 North-South Cross Street: SH 123  
 East-West Cross Street: BROADWAY ST

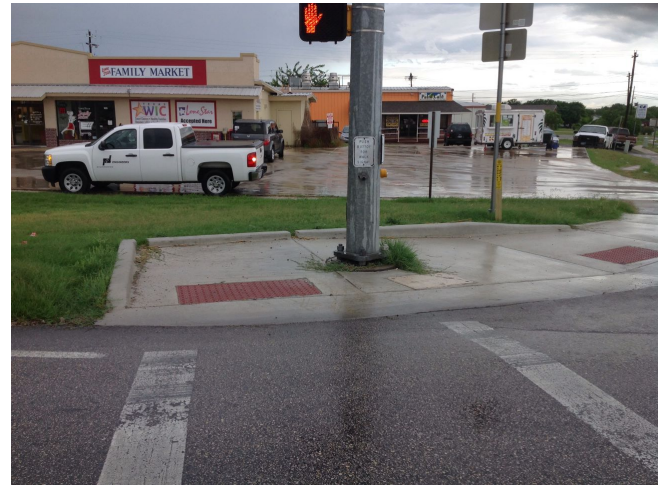
Signalized Intersection: YES  
 Accessible Features: YES  
 Pedestrian Features Accessible: NO

<b>Ramp Elements</b>	Curb ramp provided where an accessible route crosses a barrier:	YES
	Is the slope of the ramp 1:12 or less:	YES
	Transition from curb ramp slope to roadway free from abrupt changes, no greater than 1:20:	NO
	Ramp is at least 36" wide:	YES
	Ramp surface is stable, firm, and slip resistant:	YES
<b>Flare</b>	Flares (if present) are 1:10 or less measured along the curb line; or If landing at top of ramp is not provided flares are 1:12 or less:	NO
<b>Detectable Warning Surface</b>	Curb ramp is located such that it does not project into roadway or parking aisles:	N/A
	Detectable warning is present:	NO
	DWS maintains correct geometric controls; 0.9" diameter domes, 0.2" in height, spaced at 2.35" and visually contracts adjacent ramp surface:	YES
<b>Special Ramps</b>	Ramp maintains defined edges parallel to direction of pedestrian travel; maintains 4'x4' turning pad contained in crosswalk; flared sides 24" segment on each side of ramp within crosswalk lines:	N/A

Ramp is located so they will not be obstructed by parked vehicles:	N/A
	Ramp wholly contained within the crosswalk lines:	YES
	If island is present; Island maintains a cut through at street level or ramps on either side with landing between them:	N/A
