# CITY OF SAN MARCOS ADA TRANSITION PLAN SIGNALIZED INTERSECTION ASSESSMENT AND COMPLIANCE REPORT

Location ID: 000000209  
 North-South Cross Street: SH 123  
 East-West Cross Street: HAYS ST

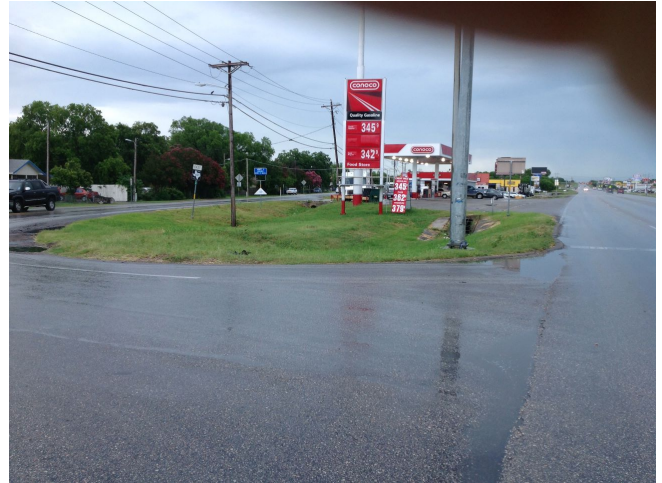
Signalized Intersection: YES  
 Accessible Features: NO  
 Pedestrian Features Accessible: NO

<b>Ramp Elements</b>	Curb ramp provided where an accessible route crosses a barrier:	NO
	Is the slope of the ramp 1:12 or less:	NO
	Transition from curb ramp slope to roadway free from abrupt changes, no greater than 1:20:	NO
	Ramp is at least 36" wide:	NO
	Ramp surface is stable, firm, and slip resistant:	NO
<b>Flare</b>	Flares (if present) are 1:10 or less measured along the curb line; or If landing at top of ramp is not provided flares are 1:12 or less:	NO
<b>Detectable Warning Surface</b>	Curb ramp is located such that it does not project into roadway or parking aisles:	N/A
	Detectable warning is present:	NO
	DWS maintains correct geometric controls; 0.9" diameter domes, 0.2" in height, spaced at 2.35" and visually contrasts adjacent ramp surface:	NO
<b>Special Ramps</b>	Ramp maintains defined edges parallel to direction of pedestrian travel; maintains 4'x4' turning pad contained in crosswalk; flared sides 24" segment on each side of ramp within crosswalk lines:	N/A

Ramp is located so they will not be obstructed by parked vehicles:	N/A
	Ramp wholly contained within the crosswalk lines:	N/A
	If island is present; Island maintains a cut through at street level or ramps on either side with landing between them:	N/A
