**CITY OF SAN MARCOS
ADA TRANSITION PLAN
SIGNALIZED INTERSECTION ASSESSMENT
AND COMPLIANCE REPORT**

Location ID: 0000000218
 North-South Cross Street: GUADALUPE ST
 East-West Cross Street: ROOSEVELT ST

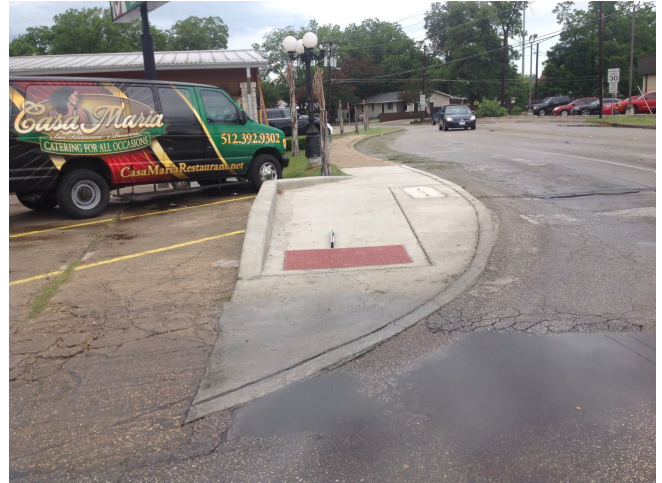
Signalized Intersection: YES
 Accessible Features: NO
 Pedestrian Features Accessible: NO

Ramp Elements	Curb ramp provided where an accessible route crosses a barrier:	NO
	Is the slope of the ramp 1:12 or less:	YES
	Transition from curb ramp slope to roadway free from abrupt changes, no greater than 1:20:	YES
	Ramp is at least 36" wide:	YES
	Ramp surface is stable, firm, and slip resistant:	YES
Flare	Flares (if present) are 1:10 or less measured along the curb line; or If landing at top of ramp is not provided flares are 1:12 or less:	N/A
Detectable Warning Surface	Curb ramp is located such that it does not project into roadway or parking aisles:	N/A
	Detectable warning is present:	YES
	DWS maintains correct geometric controls; 0.9" diameter domes, 0.2" in height, spaced at 2.35" and visually contracts adjacent ramp surface:	YES
Special Ramps	Ramp maintains defined edges parallel to direction of pedestrian travel; maintains 4'x4' turning pad contained in crosswalk; flared sides 24" segment on each side of ramp within crosswalk lines:	N/A

Ramp is located so they will not be obstructed by parked vehicles:	N/A
	Ramp wholly contained within the crosswalk lines:	N/A
	If island is present; Island maintains a cut through at street level or ramps on either side with landing between them:	N/A
