**CITY OF SAN MARCOS
ADA TRANSITION PLAN
SIGNALIZED INTERSECTION ASSESSMENT
AND COMPLIANCE REPORT**

Location ID: 0000000219
 North-South Cross Street: LBJ DR
 East-West Cross Street: CHEATHAM ST

Date of Evaluation: 6/25/2014
 Latitude: 29.876668 Longitude: -97.938907
<https://maps.google.com/maps?t=h&q=29.876668+-97.938907>

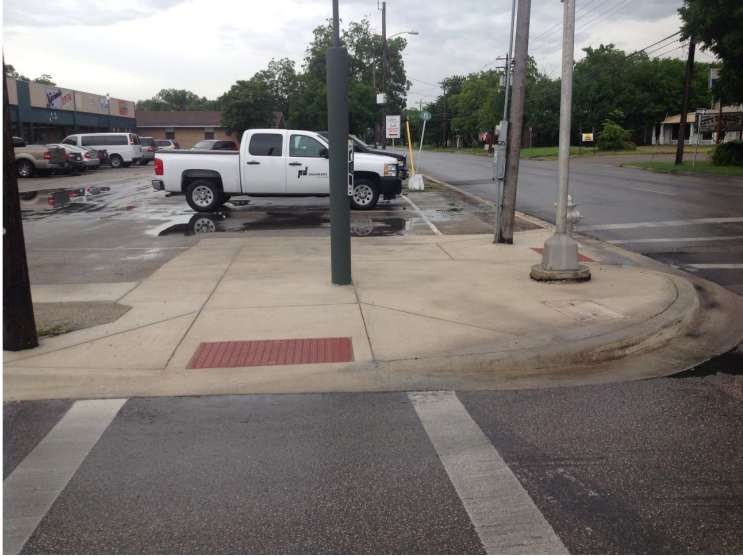
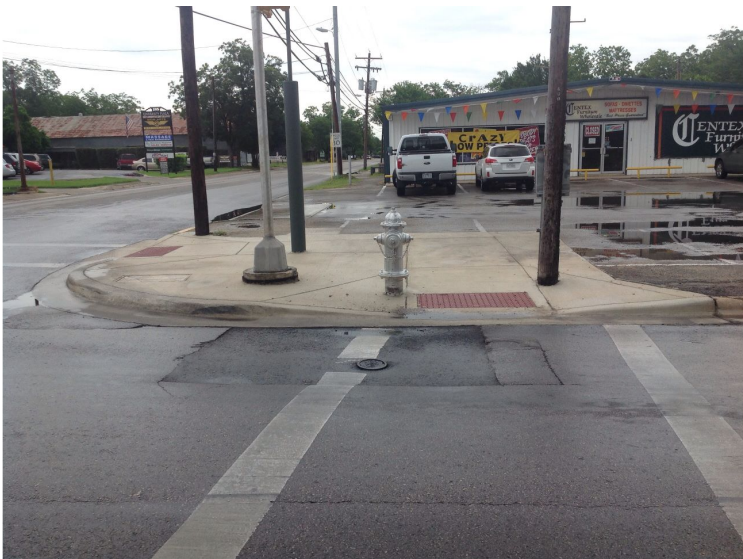
Location Photos

Ramp Elements	Curb ramp provided where an accessible route crosses a barrier:	YES
	Is the slope of the ramp 1:12 or less:	YES
	Transition from curb ramp slope to roadway free from abrupt changes, no greater than 1:20:	YES
	Ramp is at least 36" wide:	YES
	Ramp surface is stable, firm, and slip resistant:	YES
Flare	Flares (if present) are 1:10 or less measured along the curb line; or If landing at top of ramp is not provided flares are 1:12 or less:	YES
Detectable Warning Surface	Curb ramp is located such that it does not project into roadway or parking aisles:	N/A
	Detectable warning is present:	YES
	DWS maintains correct geometric controls; 0.9" diameter domes, 0.2" in height, spaced at 2.35" and visually contracts adjacent ramp surface:	YES
Special Ramps	Ramp maintains defined edges parallel to direction of pedestrian travel; maintains 4'x4' turning pad contained in crosswalk; flared sides 24" segment on each side of ramp within crosswalk lines:	N/A

Ramp is located so they will not be obstructed by parked vehicles:	N/A
	Ramp wholly contained within the crosswalk lines:	YES
	If island is present; Island maintains a cut through at street level or ramps on either side with landing between them:	N/A
