# CITY OF SAN MARCOS ADA TRANSITION PLAN SIGNALIZED INTERSECTION ASSESSMENT AND COMPLIANCE REPORT

Location ID: 0000000223  
 North-South Cross Street: HOPKINS ST  
 East-West Cross Street: BISHOP ST

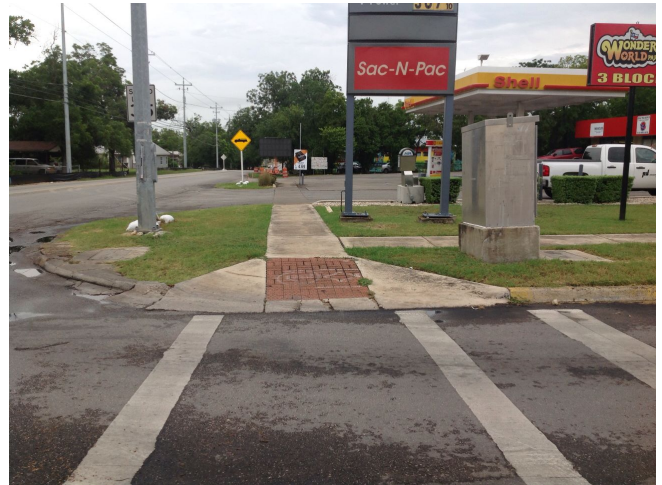
Signalized Intersection: YES  
 Accessible Features: NO  
 Pedestrian Features Accessible: NO

<b>Ramp Elements</b>	Curb ramp provided where an accessible route crosses a barrier:	YES
	Is the slope of the ramp 1:12 or less:	YES
	Transition from curb ramp slope to roadway free from abrupt changes, no greater than 1:20:	YES
	Ramp is at least 36" wide:	YES
	Ramp surface is stable, firm, and slip resistant:	YES
<b>Flare</b>	Flares (if present) are 1:10 or less measured along the curb line; or If landing at top of ramp is not provided flares are 1:12 or less:	YES
<b>Detectable Warning Surface</b>	Curb ramp is located such that it does not project into roadway or parking aisles:	N/A
	Detectable warning is present:	YES
	DWS maintains correct geometric controls; 0.9" diameter domes, 0.2" in height, spaced at 2.35" and visually contrasts adjacent ramp surface:	YES
<b>Special Ramps</b>	Ramp maintains defined edges parallel to direction of pedestrian travel; maintains 4'x4' turning pad contained in crosswalk; flared sides 24" segment on each side of ramp within crosswalk lines:	N/A

Ramp is located so they will not be obstructed by parked vehicles:	N/A
	Ramp wholly contained within the crosswalk lines:	YES
	If island is present; Island maintains a cut through at street level or ramps on either side with landing between them:	N/A
