CITY OF SAN MARCOS ADA TRANSITION PLAN SIGNALIZED INTERSECTION ASSESSMENT AND COMPLIANCE REPORT

Location ID: 0000000236
 North-South Cross Street: CRADDOCK AVE
 East-West Cross Street: RANCHROAD 12

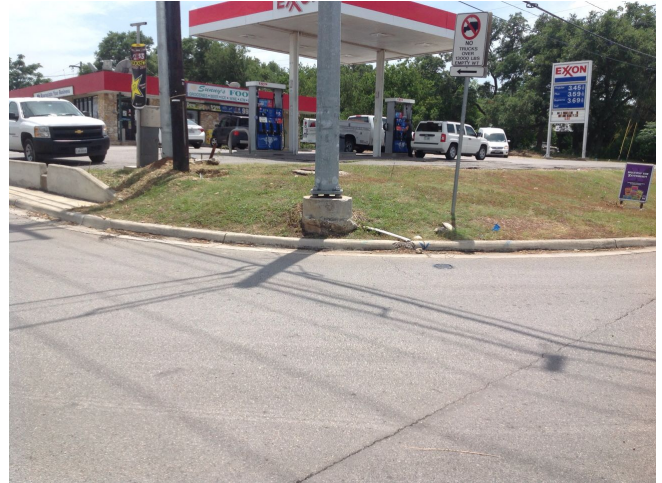
Signalized Intersection: YES
 Accessible Features: NO
 Pedestrian Features Accessible: NO

Ramp Elements	Curb ramp provided where an accessible route crosses a barrier:	NO
	Is the slope of the ramp 1:12 or less:	NO
	Transition from curb ramp slope to roadway free from abrupt changes, no greater than 1:20:	NO
	Ramp is at least 36" wide:	NO
	Ramp surface is stable, firm, and slip resistant:	NO
Flare	Flares (if present) are 1:10 or less measured along the curb line; or If landing at top of ramp is not provided flares are 1:12 or less:	NO
Detectable Warning Surface	Curb ramp is located such that it does not project into roadway or parking aisles:	N/A
	Detectable warning is present:	NO
	DWS maintains correct geometric controls; 0.9" diameter domes, 0.2" in height, spaced at 2.35" and visually contracts adjacent ramp surface:	NO
Special Ramps	Ramp maintains defined edges parallel to direction of pedestrian travel; maintains 4'x4' turning pad contained in crosswalk; flared sides 24" segment on each side of ramp within crosswalk lines:	N/A
