**CITY OF SAN MARCOS
ADA TRANSITION PLAN
SIGNALIZED INTERSECTION ASSESSMENT
AND COMPLIANCE REPORT**

Location ID: 0000000238
 North-South Cross Street: HUGHSON
 East-West Cross Street: RANCH RD 12

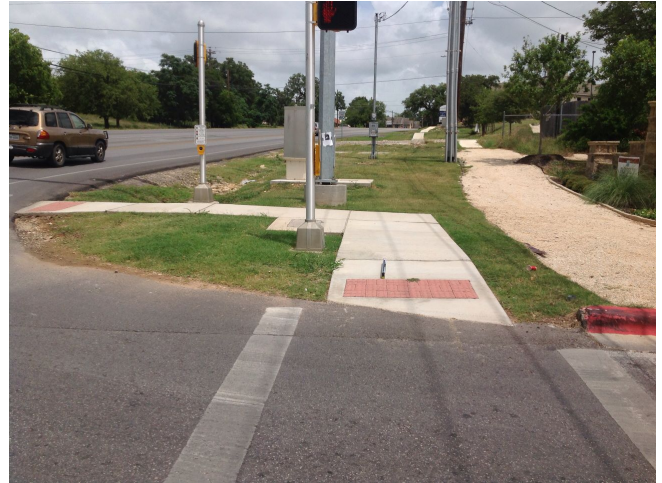
Signalized Intersection: YES
 Accessible Features: YES
 Pedestrian Features Accessible: YES

Ramp Elements	Curb ramp provided where an accessible route crosses a barrier:	YES
	Is the slope of the ramp 1:12 or less:	YES
	Transition from curb ramp slope to roadway free from abrupt changes, no greater than 1:20:	YES
	Ramp is at least 36" wide:	YES
	Ramp surface is stable, firm, and slip resistant:	YES
Flare	Flares (if present) are 1:10 or less measured along the curb line; or If landing at top of ramp is not provided flares are 1:12 or less:	N/A
Detectable Warning Surface	Curb ramp is located such that it does not project into roadway or parking aisles:	N/A
	Detectable warning is present:	YES
	DWS maintains correct geometric controls; 0.9" diameter domes, 0.2" in height, spaced at 2.35" and visually contracts adjacent ramp surface:	YES
Special Ramps	Ramp maintains defined edges parallel to direction of pedestrian travel; maintains 4'x4' turning pad contained in crosswalk; flared sides 24" segment on each side of ramp within crosswalk lines:	N/A

Ramp is located so they will not be obstructed by parked vehicles:	N/A
	Ramp wholly contained within the crosswalk lines:	YES
	If island is present; Island maintains a cut through at street level or ramps on either side with landing between them:	N/A
