**CITY OF SAN MARCOS
ADA TRANSITION PLAN
SIGNALIZED INTERSECTION ASSESSMENT
AND COMPLIANCE REPORT**

Location ID: 0000000239
 North-South Cross Street: HUGHSON
 East-West Cross Street: RANCH RD 12

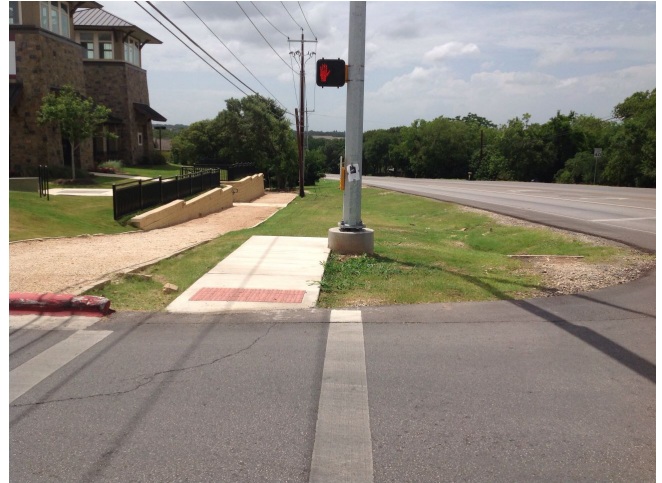
Signalized Intersection: YES
 Accessible Features: YES
 Pedestrian Features Accessible: YES

Ramp Elements	Curb ramp provided where an accessible route crosses a barrier:	YES
	Is the slope of the ramp 1:12 or less:	YES
	Transition from curb ramp slope to roadway free from abrupt changes, no greater than 1:20:	YES
	Ramp is at least 36" wide:	YES
	Ramp surface is stable, firm, and slip resistant:	YES
Flare	Flares (if present) are 1:10 or less measured along the curb line; or If landing at top of ramp is not provided flares are 1:12 or less:	N/A
Detectable Warning Surface	Curb ramp is located such that it does not project into roadway or parking aisles:	N/A
	Detectable warning is present:	YES
	DWS maintains correct geometric controls; 0.9" diameter domes, 0.2" in height, spaced at 2.35" and visually contracts adjacent ramp surface:	YES
Special Ramps	Ramp maintains defined edges parallel to direction of pedestrian travel; maintains 4'x4' turning pad contained in crosswalk; flared sides 24" segment on each side of ramp within crosswalk lines:	N/A

Ramp is located so they will not be obstructed by parked vehicles:	N/A
	Ramp wholly contained within the crosswalk lines:	YES
	If island is present; Island maintains a cut through at street level or ramps on either side with landing between them:	N/A
