**CITY OF SAN MARCOS  
ADA TRANSITION PLAN  
SIGNALIZED INTERSECTION ASSESSMENT  
AND COMPLIANCE REPORT**

Location ID: 000000242  
 North-South Cross Street: SESSOM DR  
 East-West Cross Street: COMANCHE ST

Location ID: 0000000242

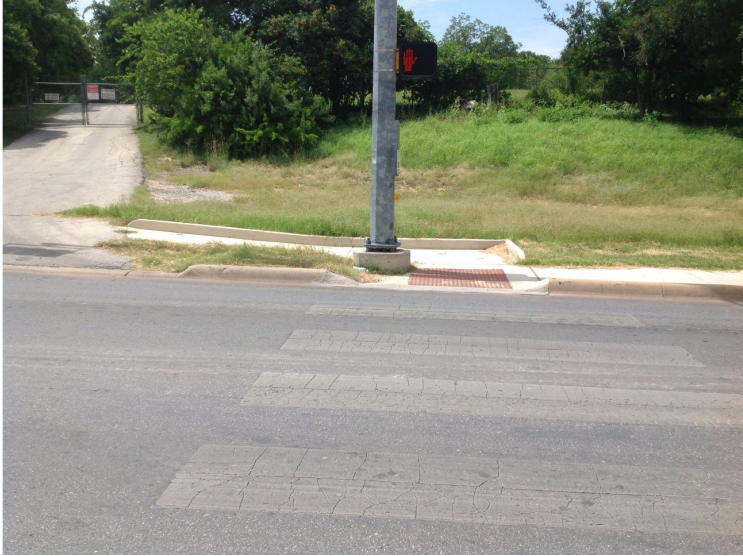
**Location Photos**

<b>Ramp Elements</b>	Curb ramp provided where an accessible route crosses a barrier:	YES
	Is the slope of the ramp 1:12 or less:	YES
	Transition from curb ramp slope to roadway free from abrupt changes, no greater than 1:20:	YES
	Ramp is at least 36" wide:	YES
	Ramp surface is stable, firm, and slip resistant:	YES
<b>Flare</b>	Flares (if present) are 1:10 or less measured along the curb line; or If landing at top of ramp is not provided flares are 1:12 or less:	NO
<b>Detectable Warning Surface</b>	Curb ramp is located such that it does not project into roadway or parking aisles:	N/A
	Detectable warning is present:	NO
	DWS maintains correct geometric controls; 0.9" diameter domes, 0.2" in height, spaced at 2.35" and visually contrasts adjacent ramp surface:	YES
<b>Special Ramps</b>	Ramp maintains defined edges parallel to direction of pedestrian travel; maintains 4'x4' turning pad contained in crosswalk; flared sides 24" segment on each side of ramp within crosswalk lines:	N/A

Ramp is located so they will not be obstructed by parked vehicles:	N/A
	Ramp wholly contained within the crosswalk lines:	YES
	If island is present; Island maintains a cut through at street level or ramps on either side with landing between them:	N/A
