# CITY OF SAN MARCOS ADA TRANSITION PLAN SIGNALIZED INTERSECTION ASSESSMENT AND COMPLIANCE REPORT

Location ID: 0000000250  
 North-South Cross Street: HUTCHISON ST  
 East-West Cross Street: MOORE ST

Signalized Intersection: YES  
 Accessible Features: NO  
 Pedestrian Features Accessible: NO

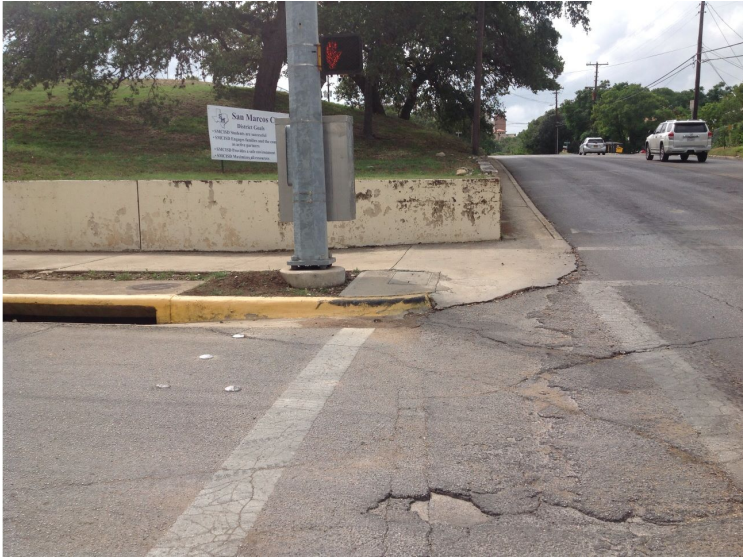
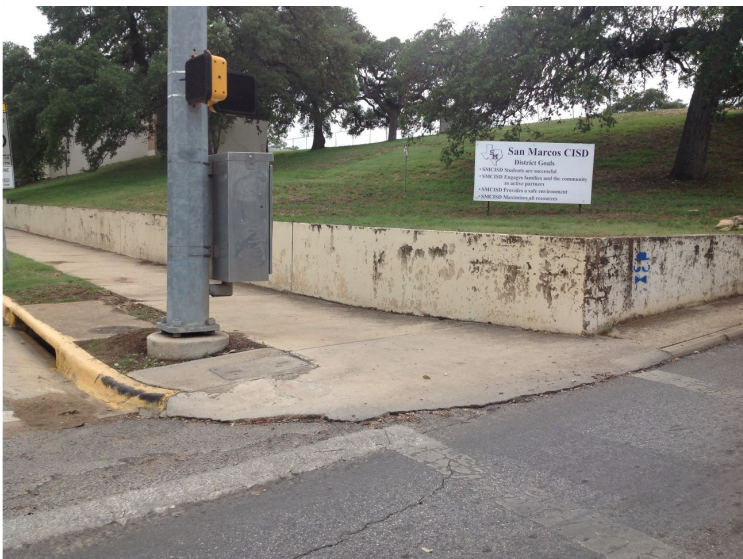
## Location Photos

<b>Ramp Elements</b>	Curb ramp provided where an accessible route crosses a barrier:	YES
	Is the slope of the ramp 1:12 or less:	NO
	Transition from curb ramp slope to roadway free from abrupt changes, no greater than 1:20:	NO
	Ramp is at least 36" wide:	YES
	Ramp surface is stable, firm, and slip resistant:	YES
<b>Flare</b>	Flares (if present) are 1:10 or less measured along the curb line; or If landing at top of ramp is not provided flares are 1:12 or less:	NO
<b>Detectable Warning Surface</b>	Curb ramp is located such that it does not project into roadway or parking aisles:	N/A
	Detectable warning is present:	NO
	DWS maintains correct geometric controls; 0.9" diameter domes, 0.2" in height, spaced at 2.35" and visually contracts adjacent ramp surface:	NO
<b>Special Ramps</b>	Ramp maintains defined edges parallel to direction of pedestrian travel; maintains 4'x4' turning pad contained in crosswalk; flared sides 24" segment on each side of ramp within crosswalk lines:	NO

Ramp is located so they will not be obstructed by parked vehicles:	N/A
	Ramp wholly contained within the crosswalk lines:	YES
	If island is present; Island maintains a cut through at street level or ramps on either side with landing between them:	N/A
