CITY OF SAN MARCOS ADA TRANSITION PLAN SIGNALIZED INTERSECTION ASSESSMENT AND COMPLIANCE REPORT

Location ID: 0000000255
 North-South Cross Street: GARRISON ST
 East-West Cross Street: GUADALUPE ST

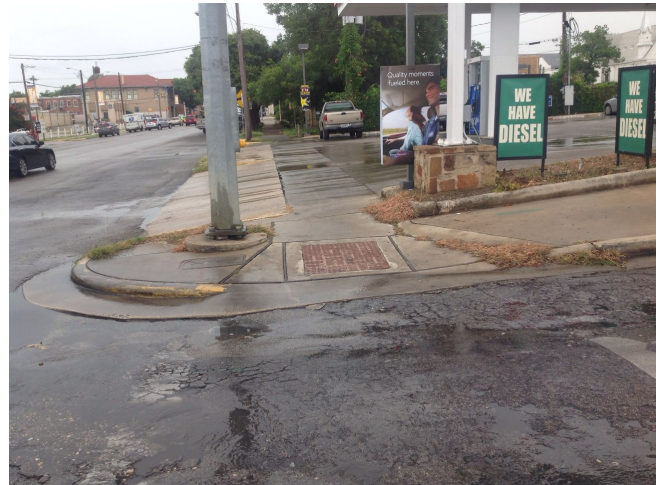
Signalized Intersection: YES
 Accessible Features: YES
 Pedestrian Features Accessible: YES

Ramp Elements	Curb ramp provided where an accessible route crosses a barrier:	YES
	Is the slope of the ramp 1:12 or less:	YES
	Transition from curb ramp slope to roadway free from abrupt changes, no greater than 1:20:	NO
	Ramp is at least 36" wide:	YES
	Ramp surface is stable, firm, and slip resistant:	YES
Flare	Flares (if present) are 1:10 or less measured along the curb line; or If landing at top of ramp is not provided flares are 1:12 or less:	YES
Detectable Warning Surface	Curb ramp is located such that it does not project into roadway or parking aisles:	N/A
	Detectable warning is present:	NO
	DWS maintains correct geometric controls; 0.9" diameter domes, 0.2" in height, spaced at 2.35" and visually contrasts adjacent ramp surface:	YES
Special Ramps	Ramp maintains defined edges parallel to direction of pedestrian travel; maintains 4'x4' turning pad contained in crosswalk; flared sides 24" segment on each side of ramp within crosswalk lines:	N/A

Ramp is located so they will not be obstructed by parked vehicles:	N/A
	Ramp wholly contained within the crosswalk lines:	YES
	If island is present; Island maintains a cut through at street level or ramps on either side with landing between them:	N/A
