**CITY OF SAN MARCOS
ADA TRANSITION PLAN
SIGNALIZED INTERSECTION ASSESSMENT
AND COMPLIANCE REPORT**

Location ID: 0000000266
 North-South Cross Street: HOPKINS ST
 East-West Cross Street: GUADALUPE ST

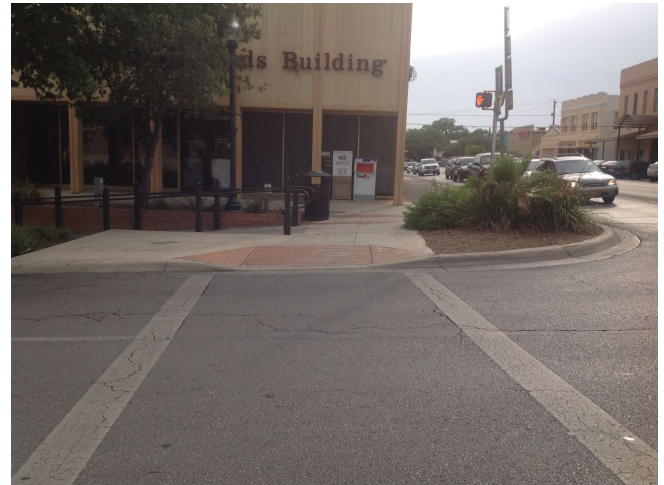
Signalized Intersection: YES
 Accessible Features: NO
 Pedestrian Features Accessible: NO

Ramp Elements	Curb ramp provided where an accessible route crosses a barrier:	YES
	Is the slope of the ramp 1:12 or less:	NO
	Transition from curb ramp slope to roadway free from abrupt changes, no greater than 1:20:	YES
	Ramp is at least 36" wide:	YES
	Ramp surface is stable, firm, and slip resistant:	YES
Flare	Flares (if present) are 1:10 or less measured along the curb line; or If landing at top of ramp is not provided flares are 1:12 or less:	NO
Detectable Warning Surface	Curb ramp is located such that it does not project into roadway or parking aisles:	N/A
	Detectable warning is present:	NO
	DWS maintains correct geometric controls; 0.9" diameter domes, 0.2" in height, spaced at 2.35" and visually contracts adjacent ramp surface:	NO
Special Ramps	Ramp maintains defined edges parallel to direction of pedestrian travel; maintains 4'x4' turning pad contained in crosswalk; flared sides 24" segment on each side of ramp within crosswalk lines:	N/A

Ramp is located so they will not be obstructed by parked vehicles:	N/A
	Ramp wholly contained within the crosswalk lines:	YES
	If island is present; Island maintains a cut through at street level or ramps on either side with landing between them:	N/A
