CITY OF SAN MARCOS ADA TRANSITION PLAN SIGNALIZED INTERSECTION ASSESSMENT AND COMPLIANCE REPORT

Location ID: 0000000270
 North-South Cross Street: SAN ANTONIO ST
 East-West Cross Street: LBJ ST

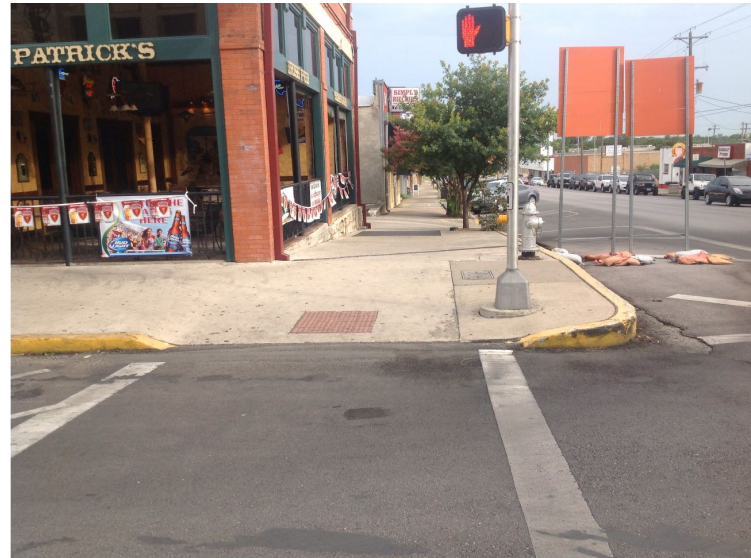
Location Photos

Ramp Elements	Curb ramp provided where an accessible route crosses a barrier:	YES
	Is the slope of the ramp 1:12 or less:	YES
	Transition from curb ramp slope to roadway free from abrupt changes, no greater than 1:20:	YES
	Ramp is at least 36" wide:	YES
	Ramp surface is stable, firm, and slip resistant:	YES
Flare	Flares (if present) are 1:10 or less measured along the curb line; or If landing at top of ramp is not provided flares are 1:12 or less:	NO
Detectable Warning Surface	Curb ramp is located such that it does not project into roadway or parking aisles:	YES
	Detectable warning is present:	NO
	DWS maintains correct geometric controls; 0.9" diameter domes, 0.2" in height, spaced at 2.35" and visually contracts adjacent ramp surface:	YES
Special Ramps	Ramp maintains defined edges parallel to direction of pedestrian travel; maintains 4'x4' turning pad contained in crosswalk; flared sides 24" segment on each side of ramp within crosswalk lines:	N/A

Ramp is located so they will not be obstructed by parked vehicles:	YES
	Ramp wholly contained within the crosswalk lines:	YES
	If island is present; Island maintains a cut through at street level or ramps on either side with landing between them:	N/A
