CITY OF SAN MARCOS ADA TRANSITION PLAN SIGNALIZED INTERSECTION ASSESSMENT AND COMPLIANCE REPORT

Location ID: 0000000271
 North-South Cross Street: HUTCHISON ST
 East-West Cross Street: GUADALUPE ST

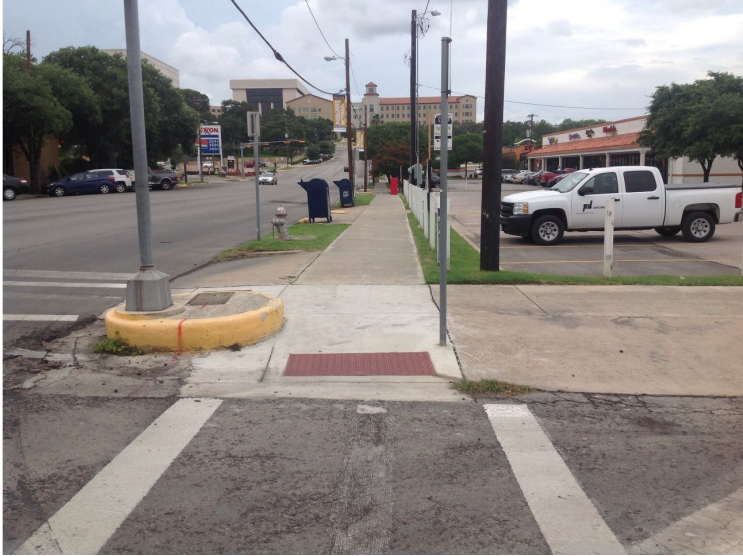
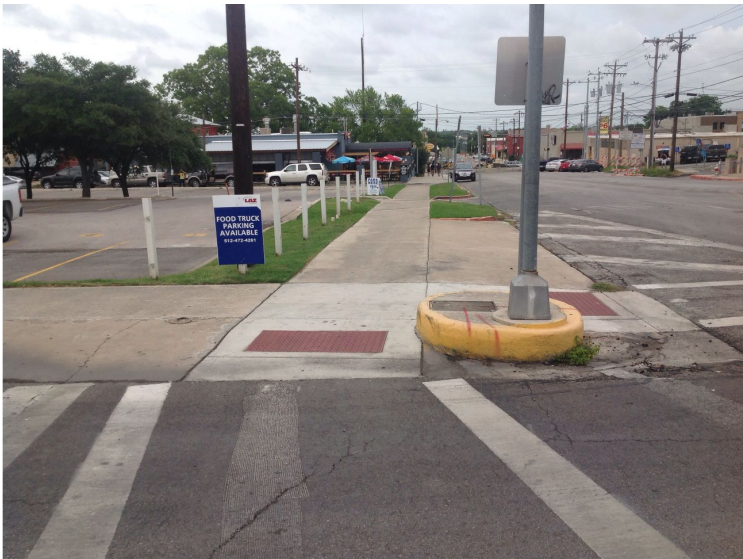
Location Photos

Ramp Elements	Curb ramp provided where an accessible route crosses a barrier:	YES
	Is the slope of the ramp 1:12 or less:	YES
	Transition from curb ramp slope to roadway free from abrupt changes, no greater than 1:20:	YES
	Ramp is at least 36" wide:	YES
	Ramp surface is stable, firm, and slip resistant:	YES
Flare	Flares (if present) are 1:10 or less measured along the curb line; or If landing at top of ramp is not provided flares are 1:12 or less:	YES
Detectable Warning Surface	Curb ramp is located such that it does not project into roadway or parking aisles:	N/A
	Detectable warning is present:	YES
	DWS maintains correct geometric controls; 0.9" diameter domes, 0.2" in height, spaced at 2.35" and visually contracts adjacent ramp surface:	YES
Special Ramps	Ramp maintains defined edges parallel to direction of pedestrian travel; maintains 4'x4' turning pad contained in crosswalk; flared sides 24" segment on each side of ramp within crosswalk lines:	N/A

Ramp is located so they will not be obstructed by parked vehicles:	N/A
	Ramp wholly contained within the crosswalk lines:	YES
	If island is present; Island maintains a cut through at street level or ramps on either side with landing between them:	N/A
