**CITY OF SAN MARCOS  
ADA TRANSITION PLAN  
SIGNALIZED INTERSECTION ASSESSMENT  
AND COMPLIANCE REPORT**

Location ID: 0000000279  
 North-South Cross Street: SESSOM DR  
 East-West Cross Street: PEQUES ST

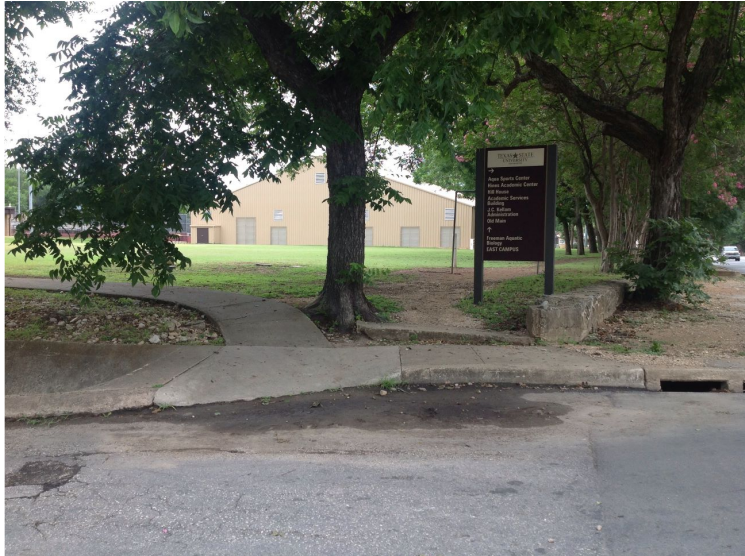
**Location Photos**

<b>Ramp Elements</b>	Curb ramp provided where an accessible route crosses a barrier:	YES
	Is the slope of the ramp 1:12 or less:	NO
	Transition from curb ramp slope to roadway free from abrupt changes, no greater than 1:20:	NO
	Ramp is at least 36" wide:	YES
	Ramp surface is stable, firm, and slip resistant:	YES
<b>Flare</b>	Flares (if present) are 1:10 or less measured along the curb line; or If landing at top of ramp is not provided flares are 1:12 or less:	NO
<b>Detectable Warning Surface</b>	Curb ramp is located such that it does not project into roadway or parking aisles:	N/A
	Detectable warning is present:	NO
	DWS maintains correct geometric controls; 0.9" diameter domes, 0.2" in height, spaced at 2.35" and visually contracts adjacent ramp surface:	NO
<b>Special Ramps</b>	Ramp maintains defined edges parallel to direction of pedestrian travel; maintains 4'x4' turning pad contained in crosswalk; flared sides 24" segment on each side of ramp within crosswalk lines:	N/A
