**CITY OF SAN MARCOS
ADA TRANSITION PLAN
SIGNALIZED INTERSECTION ASSESSMENT
AND COMPLIANCE REPORT**

Location ID: 0000000288
 North-South Cross Street: THORPE LN
 East-West Cross Street: ROBBIE LN

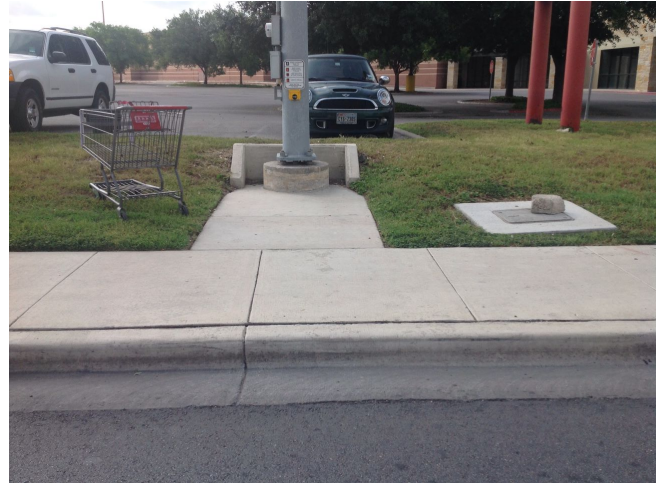
Signalized Intersection: YES
 Accessible Features: YES
 Pedestrian Features Accessible: NO

Ramp Elements	Curb ramp provided where an accessible route crosses a barrier:	NO
	Is the slope of the ramp 1:12 or less:	NO
	Transition from curb ramp slope to roadway free from abrupt changes, no greater than 1:20:	NO
	Ramp is at least 36" wide:	NO
	Ramp surface is stable, firm, and slip resistant:	NO
Flare	Flares (if present) are 1:10 or less measured along the curb line; or If landing at top of ramp is not provided flares are 1:12 or less:	N/A
Detectable Warning Surface	Curb ramp is located such that it does not project into roadway or parking aisles:	N/A
	Detectable warning is present:	NO
	DWS maintains correct geometric controls; 0.9" diameter domes, 0.2" in height, spaced at 2.35" and visually contracts adjacent ramp surface:	NO
Special Ramps	Ramp maintains defined edges parallel to direction of pedestrian travel; maintains 4'x4' turning pad contained in crosswalk; flared sides 24" segment on each side of ramp within crosswalk lines:	N/A
