CITY OF SAN MARCOS ADA TRANSITION PLAN SIGNALIZED INTERSECTION ASSESSMENT AND COMPLIANCE REPORT

Location ID: 0000000306
 North-South Cross Street: SBFR IH 35
 East-West Cross Street: TX HWY 80

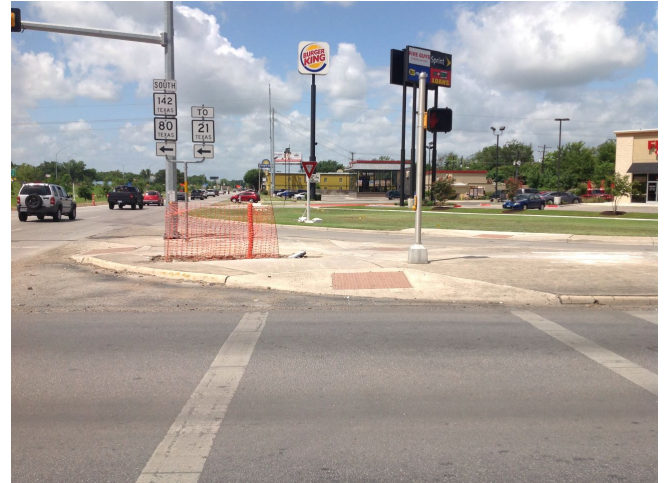
Signalized Intersection: YES
 Accessible Features: YES
 Pedestrian Features Accessible: NO

Ramp Elements	Curb ramp provided where an accessible route crosses a barrier:	YES
	Is the slope of the ramp 1:12 or less:	YES
	Transition from curb ramp slope to roadway free from abrupt changes, no greater than 1:20:	NO
	Ramp is at least 36" wide:	YES
	Ramp surface is stable, firm, and slip resistant:	YES
Flare	Flares (if present) are 1:10 or less measured along the curb line; or If landing at top of ramp is not provided flares are 1:12 or less:	YES
Detectable Warning Surface	Curb ramp is located such that it does not project into roadway or parking aisles:	YES
	Detectable warning is present:	YES
	DWS maintains correct geometric controls; 0.9" diameter domes, 0.2" in height, spaced at 2.35" and visually contracts adjacent ramp surface:	YES
Special Ramps	Ramp maintains defined edges parallel to direction of pedestrian travel; maintains 4'x4' turning pad contained in crosswalk; flared sides 24" segment on each side of ramp within crosswalk lines:	N/A

Ramp is located so they will not be obstructed by parked vehicles:	N/A
	Ramp wholly contained within the crosswalk lines:	YES
	If island is present; Island maintains a cut through at street level or ramps on either side with landing between them:	N/A
