**CIVIC/CONVENTION CENTER
375 South Castell Avenue
New Braunfels, TX 78130**

ADA SELF-EVALUATION FACILITY SURVEY

New Braunfels Civic/Convention Center

Jun 29, 2021

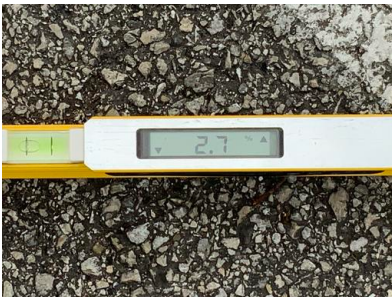
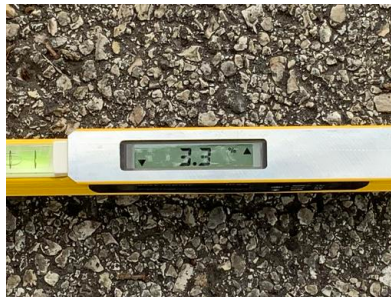
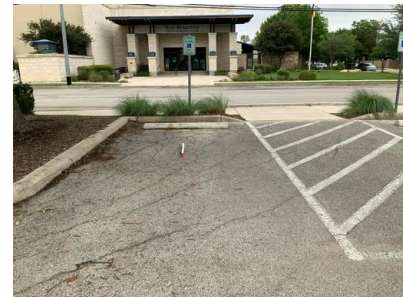
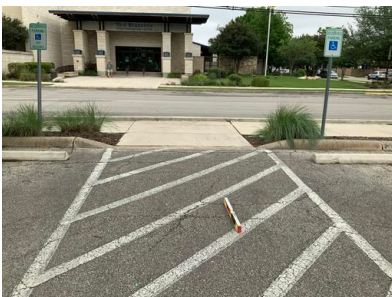
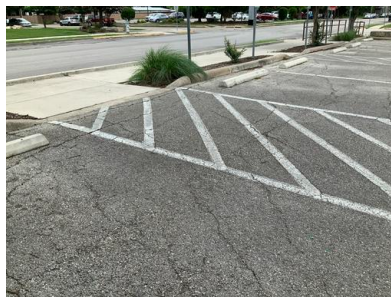
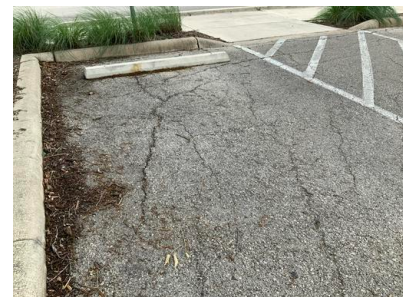
#1 Priority 1: Parking

Description
The van accessible parking space and access aisle have a running slope of up to 3.3% and has some cracking and gaps in the asphalt.

Recommendation: Replace asphalt surface at parking space and access aisle.

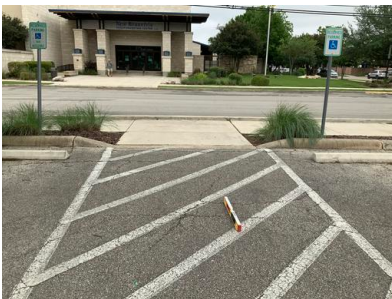
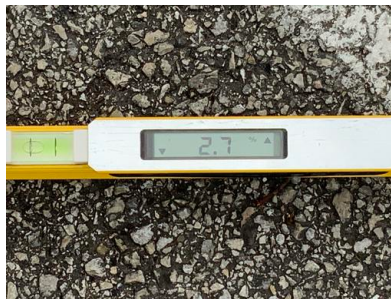
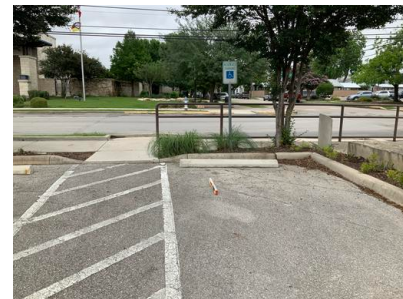
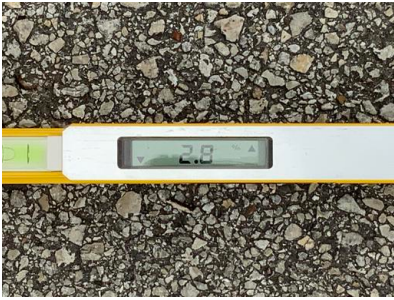
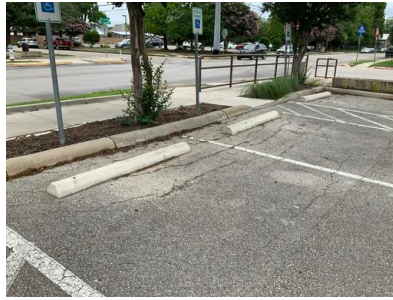
#3 Priority 1: Parking

The three easternmost accessible parking spaces have cracking and gaps in the asphalt, and the easternmost accessible parking space has a running slope of up to 2.8%.

Recommendation: Replace asphalt surface at parking spaces and access aisles.

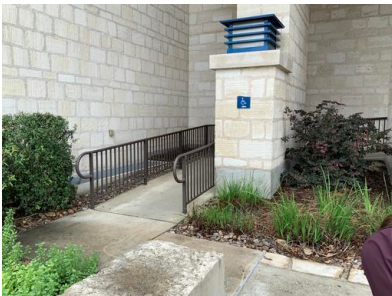
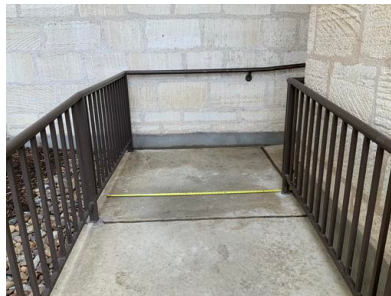
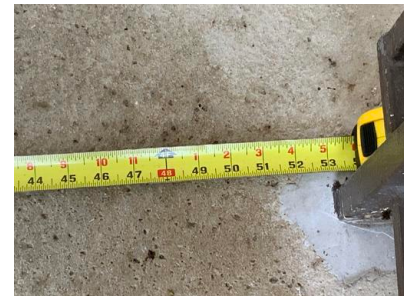
#7 Priority 1: Ramps

- 1) Excessive gaps surrounding the bottom landing
- 2) Missing handrail extension on one side of the top and bottom landings
- 3) Intermediate landing is less than 60" x 60" clear
- 4) Upper landing has a cross slope of approximately 2.8%

Recommendation: Remove and replace ramp.

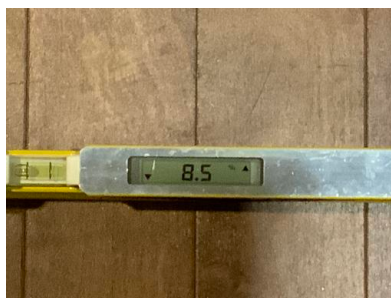
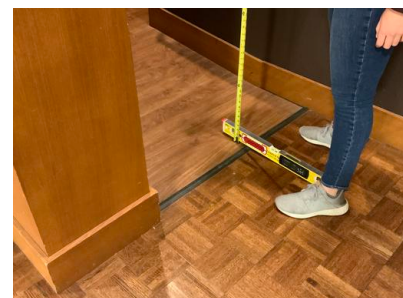
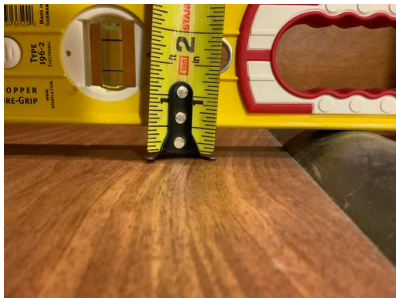
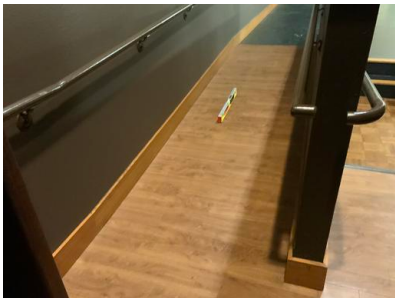
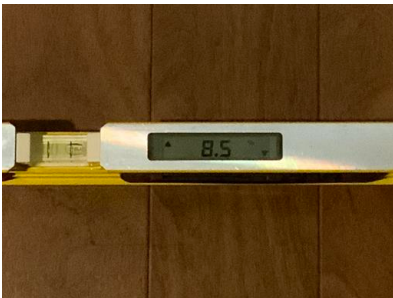
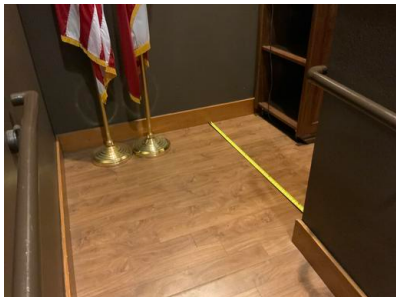
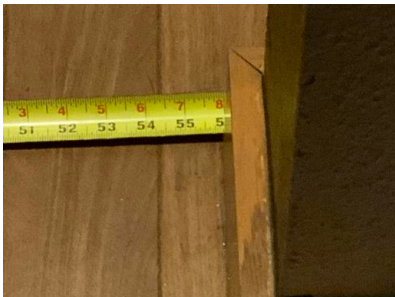
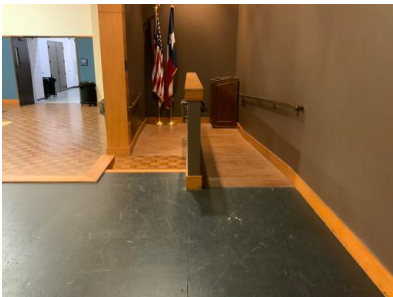
The ramp to the stage has the following noncompliant conditions:

Recommendation: Remove and replace ramp.

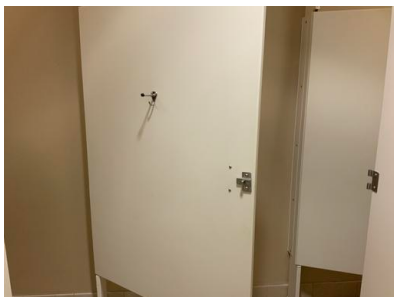
#45 Priority 3: Toilet Compartments

Recommendation: Adjust door hinge.

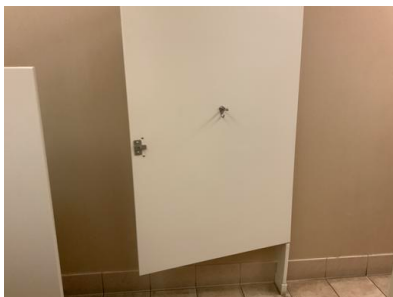
#56 Priority 3: Toilet Compartments

Recommendation: Adjust door hinges.
