**WESTSIDE COMMUNITY CENTER
2932 S IH Frontage Road
New Braunfels, TX 78130**

ADA SELF-EVALUATION FACILITY SURVEY

New Braunfels Westside Community Center

Jun 29, 2021

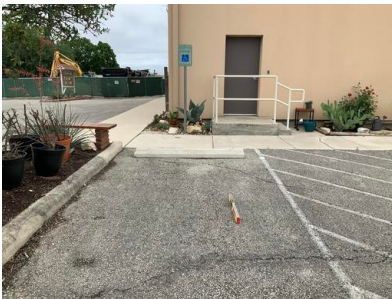
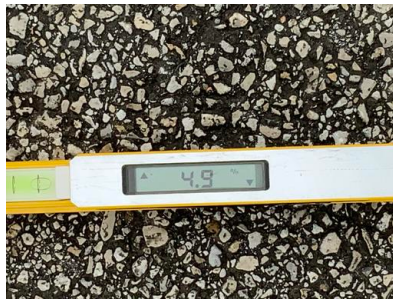
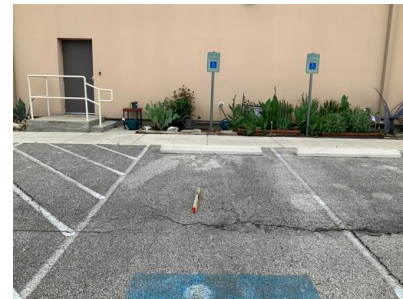
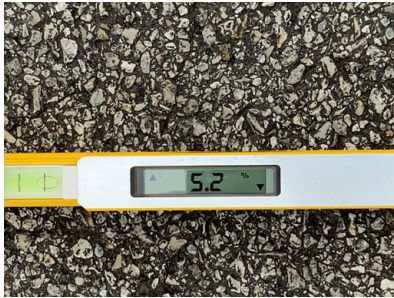
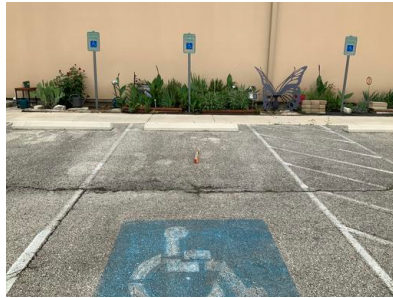
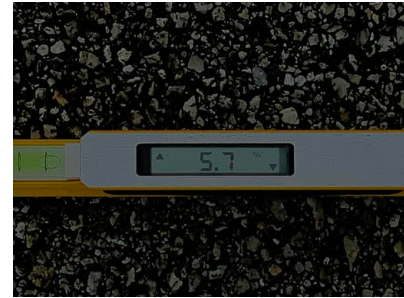
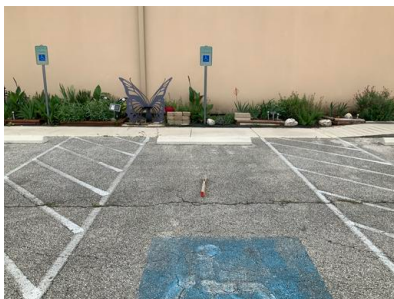
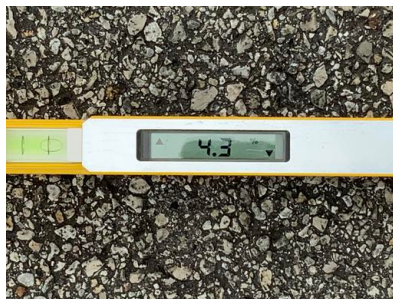
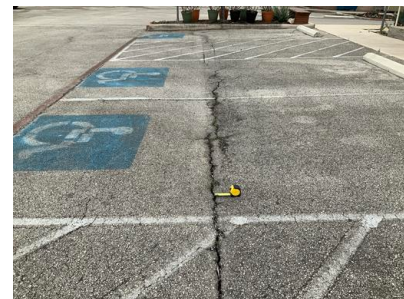
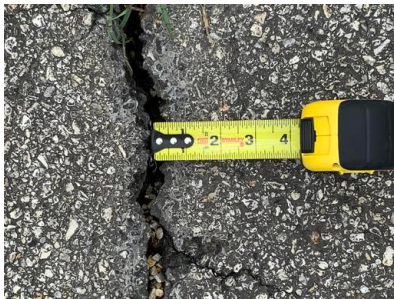
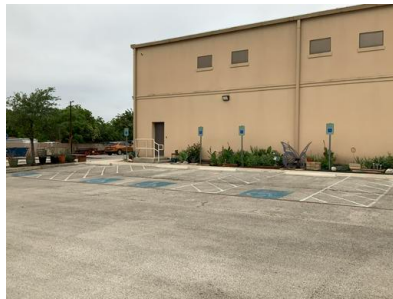
All 4 accessible parking spaces and access aisles have running slopes ranging from 4.3% to 5.9% and a crack in the asphalt.

Recommendation: Remove and replace asphalt in this area.

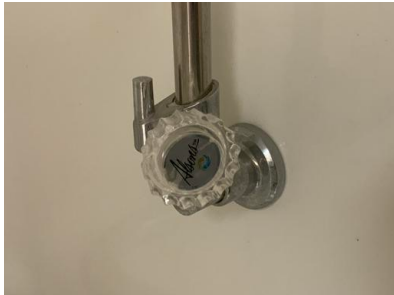
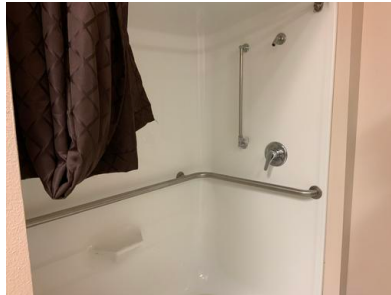
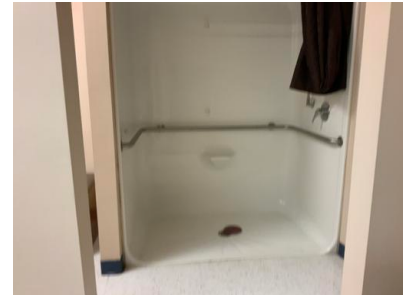
The accessible shower is not equipped with a handheld shower wand (missing), and the knob adjustment requires tight grasping and twisting of the wrist.

Recommendation: Install a compliant handheld shower assembly.
