**CITY OF SAN MARCOS
ADA TRANSITION PLAN
SIGNALIZED INTERSECTION ASSESSMENT
AND COMPLIANCE REPORT**

Location ID: 0000000139
 North-South Cross Street: SAN ANTONIO ST
 East-West Cross Street: GUADALUPE ST

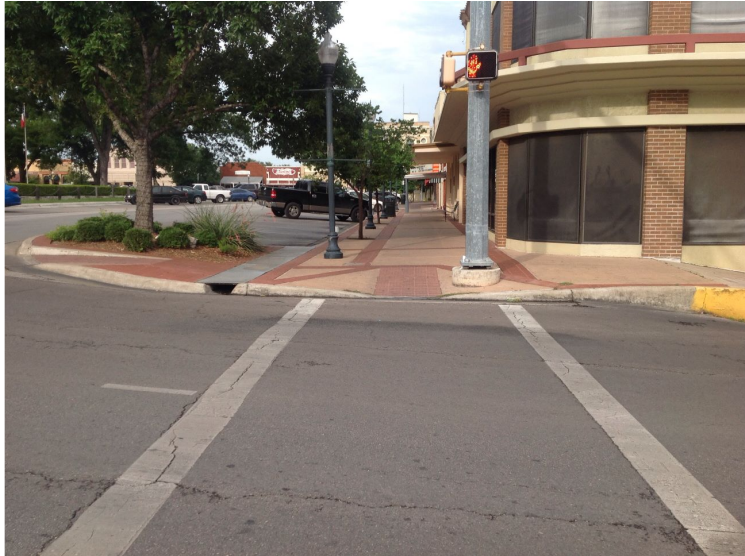
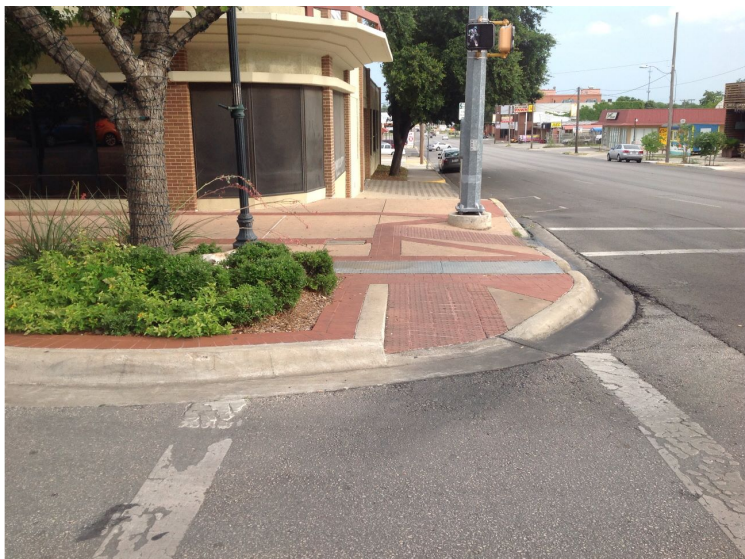
Location Photos

Ramp Elements	Curb ramp provided where an accessible route crosses a barrier:	YES
	Is the slope of the ramp 1:12 or less:	YES
	Transition from curb ramp slope to roadway free from abrupt changes, no greater than 1:20:	NO
	Ramp is at least 36" wide:	YES
	Ramp surface is stable, firm, and slip resistant:	YES
Flare	Flares (if present) are 1:10 or less measured along the curb line; or If landing at top of ramp is not provided flares are 1:12 or less:	YES
Detectable Warning Surface	Curb ramp is located such that it does not project into roadway or parking aisles:	N/A
	Detectable warning is present:	YES
	DWS maintains correct geometric controls; 0.9" diameter domes, 0.2" in height, spaced at 2.35" and visually contrasts adjacent ramp surface:	NO
Special Ramps	Ramp maintains defined edges parallel to direction of pedestrian travel; maintains 4'x4' turning pad contained in crosswalk; flared sides 24" segment on each side of ramp within crosswalk lines:	NO
