CITY OF SAN MARCOS ADA TRANSITION PLAN SIGNALIZED INTERSECTION ASSESSMENT AND COMPLIANCE REPORT

Location ID: 000000164
 North-South Cross Street: THORPE LN
 East-West Cross Street: EASTWOOD ST

Date of Evaluation: 6/27/2014

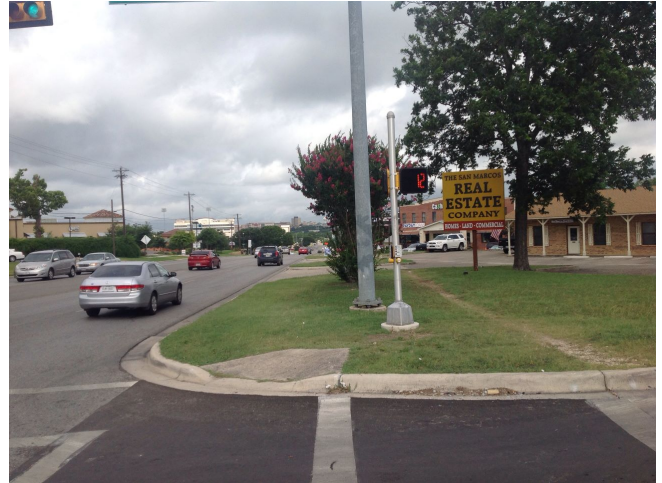
Signalized Intersection: YES
 Accessible Features: YES
 Pedestrian Features Accessible: NO

Ramp Elements	Curb ramp provided where an accessible route crosses a barrier:	YES
	Is the slope of the ramp 1:12 or less:	NO
	Transition from curb ramp slope to roadway free from abrupt changes, no greater than 1:20:	NO
	Ramp is at least 36" wide:	YES
	Ramp surface is stable, firm, and slip resistant:	YES
Flare	Flares (if present) are 1:10 or less measured along the curb line; or If landing at top of ramp is not provided flares are 1:12 or less:	NO
Detectable Warning Surface	Curb ramp is located such that it does not project into roadway or parking aisles:	N/A
	Detectable warning is present:	NO
	DWS maintains correct geometric controls; 0.9" diameter domes, 0.2" in height, spaced at 2.35" and visually contracts adjacent ramp surface:	NO
Special Ramps	Ramp maintains defined edges parallel to direction of pedestrian travel; maintains 4'x4' turning pad contained in crosswalk; flared sides 24" segment on each side of ramp within crosswalk lines:	YES

Ramp is located so they will not be obstructed by parked vehicles:	N/A
	Ramp wholly contained within the crosswalk lines:	YES
	If island is present; Island maintains a cut through at street level or ramps on either side with landing between them:	N/A
