CITY OF SAN MARCOS ADA TRANSITION PLAN SIGNALIZED INTERSECTION ASSESSMENT AND COMPLIANCE REPORT

Location ID: 000000092
 North-South Cross Street: GUADALUPE ST
 East-West Cross Street: M L KING DR

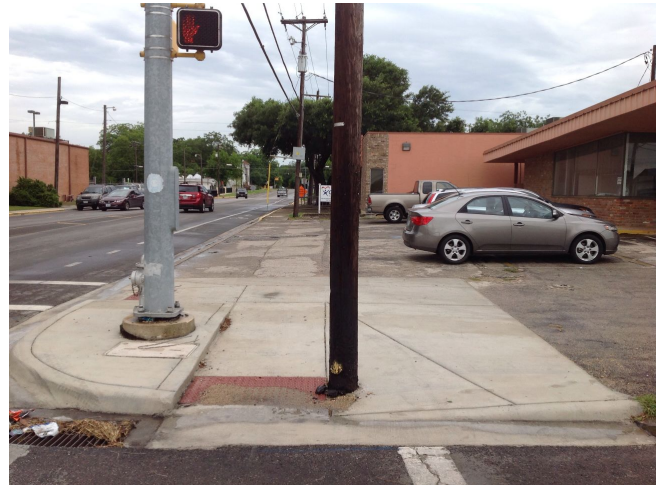
Location Details

Signalized Intersection: YES
 Accessible Features: NO
 Pedestrian Features Accessible: NO
