Utility Conflict Report

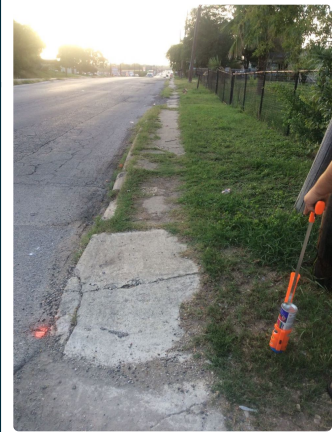
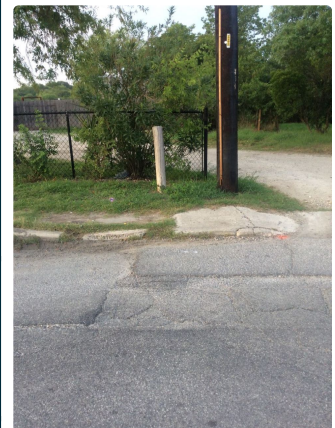
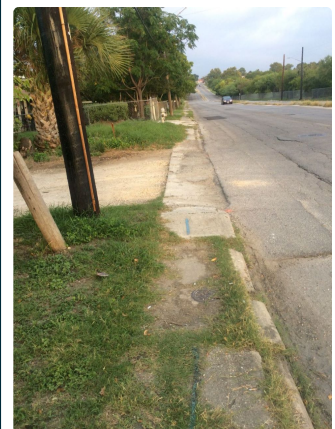
OWNER	Utility	CPS	Corridor	RIGSBY	SITE PHOTOS
	Contact	BILL FEY	ID	2057	
GENERAL INFO	Utility	GAS			
	Size and Material	STANDARD GAS VALVE, CAST IRON			
	Utility Conflict Description	GAS VALVE WITHIN PROPOSED SIDEWALK			
	Longitudinal or Crossing	CROSSING			
	Placement Relative to ROW	INSIDE			
LOCATION	Sheet No.	236			
	Station Origin				
	Start Station	106+53.30	End Station		
	Start Offset	7.72	End Offset		
	Latitude	29.397994913	Longitude	-98.441266463000005	
SUE	Level of Investigation Req'd	NONE			
	Test Hole No	N/A			
	Test Hole Depth	N/A			
RESOLUTION	Recommended Action	MINIMIZE - PROTECT IN PLACE			
	Estimated Resolution Date				
	Resolution Status	UTILITY COORDINATION IN PROGRESS

Comment	ADJUST GAS VALVE LID TO PROPOSED GRADE DURING CONSTRUCTION (1-3" VERTICAL RISE ANTICIPATED). VALVE LOCATED 7' FROM EX EDGE OF DRIVEWAY			
Date Collected		8/14/2017 7:30:49 AM	Date Modified		11/9/2017 5:45:01 PM
