Utility Conflict Report

OWNER	Utility	SAWS	Corridor	SW MILITARY	SITE PHOTOS	
	Contact	ANN PECHE	ID	3115		
GENERAL INFO	Utility	WATER

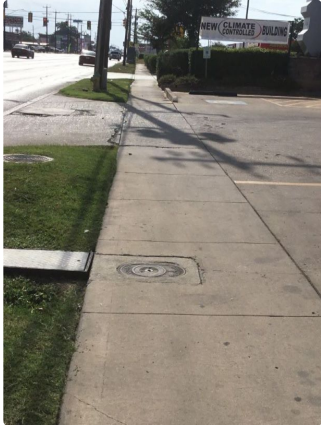
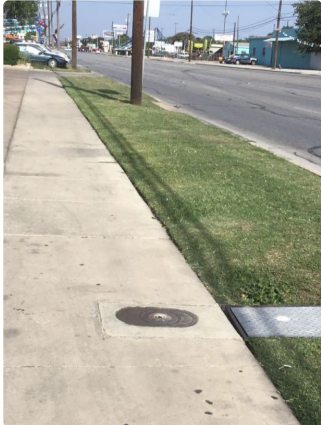
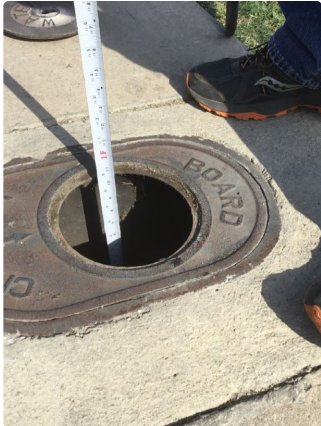
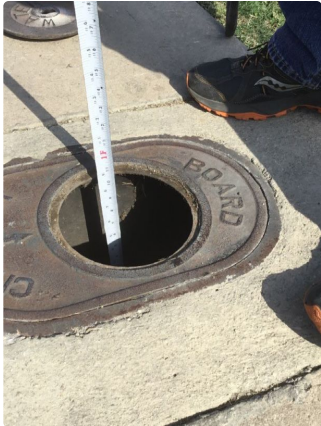
Size and Material	STANDARD WATER VALVE, CAST IRON				
	Accessible Route	ASSET IS INSIDE ACCESSIBLE ROUTE				
	Longitudinal or Crossing	CROSSING				
	Placement Relative to ROW	INSIDE ROW				
LOCATION	Sheet No.	134

Station	546+36.55				
	Offset	21.43				
	Latitude	+29.357736				
	Longitude	-98.55517				
SUE	Level of Investigation Req'd	NONE

Estimated Resolution Date					
	Resolution Status	UTILITY OWNER INFORMED OF UTILITY				
	Comment	Top of valve to surface = 10" Lid thickness = 3/8" Sidewalk width = 4'-5" Front of sidewalk to valve = 6.5"				
Date Collected		7/24/2018 9:52:09 AM		Date Modified	11/28/2018 6:59:12 AM

Test Hole No	N/A				
	Test Hole Depth	N/A				
RESOLUTION	Recommended Action	MINIMIZE - PROTECT IN PLACE
