## Utility Conflict Report

<b>OWNER</b>	<b>Utility</b>	CPS	<b>Corridor</b>	SW MILITARY	<b>SITE PHOTOS</b>	
	<b>Contact</b>	JAKE MARTINEZ	<b>ID</b>	4188		
<b>GENERAL INFO</b>	<b>Utility</b>	ELECTRIC

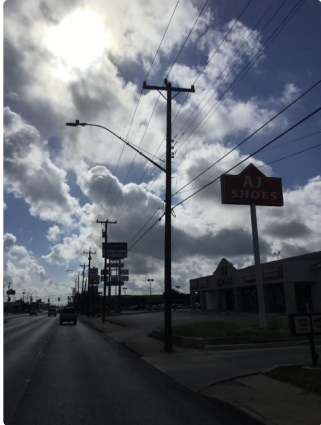
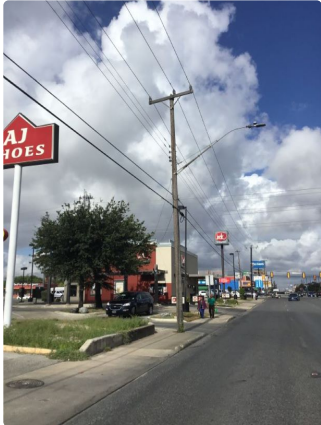
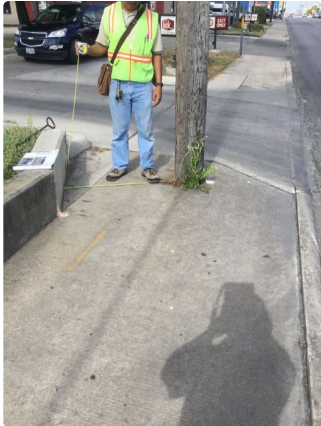
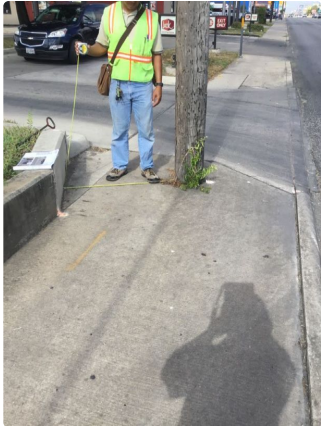
<b>Size and Material</b>	STANDARD POWER POLE, TIMBER				
	<b>Accessible Route</b>	ASSET IS INSIDE ACCESSIBLE ROUTE				
	<b>Longitudinal or Crossing</b>	CROSSING				
	<b>Placement Relative to ROW</b>	INSIDE ROW				
<b>LOCATION</b>	<b>Sheet No.</b>	162

<b>Estimated Resolution Date</b>	11/21/2018				
	<b>Resolution Status</b>	NO RESOLUTION WAS REQUIRED				
	<b>Comment</b>	Pole ID: 414372; LW 46807 Pole to back of curb = 2'-11" Pole to face of wall = 3'-7" Sidewalk width = 6'-3" min, 8'-0" max

<b>Test Hole No</b>	N/A				
	<b>Test Hole Depth</b>	N/A				
<b>RESOLUTION</b>	<b>Recommended Action</b>	NO CONFLICT
