Utility Conflict Report

OWNER	Utility	SAWS	Corridor	SW MILITARY	SITE PHOTOS
	Contact	ANN PECHE	ID	7037	
GENERAL INFO	Utility	WATER

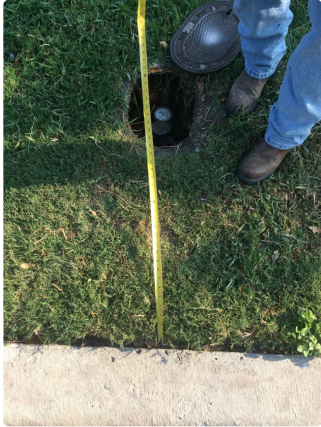
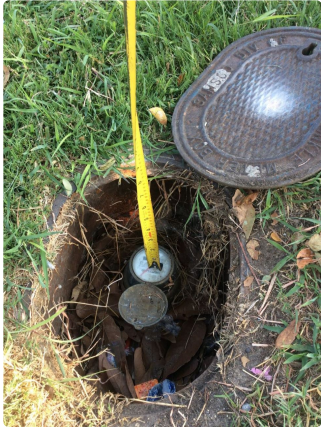
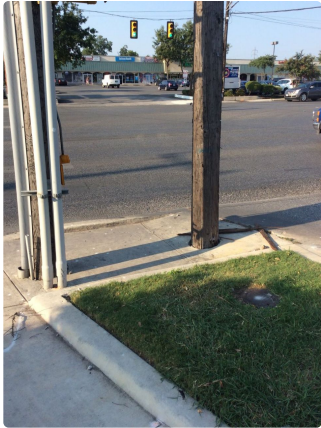
Size and Material	STANDARD WATER METER, CAST IRON			
	Accessible Route	ASSET IS OUTSIDE ACCESSIBLE ROUTE			
	Longitudinal or Crossing	CROSSING			
	Placement Relative to ROW	INSIDE ROW			
LOCATION	Sheet No.	211

Station	947+54.23			
	Offset	-23.0197			
	Latitude	+29.356821			
	Longitude	-98.50161			
SUE	Level of Investigation Req'd	NONE

Test Hole No	N/A			
	Test Hole Depth	N/A			
RESOLUTION	Recommended Action	NO CONFLICT			
	Estimated Resolution Date				
	Resolution Status	NO RESOLUTION WAS REQUIRED			
	Comment	Back of wall to meter = 2'-9" Top of meter to bottom of lid = 5"			
Date Collected		8/3/2018 8:43:58 AM		Date Modified 11/28/2018 6:59:12 AM
