Utility Conflict Report

OWNER	Utility	SAWS	Corridor	SW MILITARY	SITE PHOTOS	
	Contact	ANN PECHE	ID	7112		
GENERAL INFO	Utility	WATER

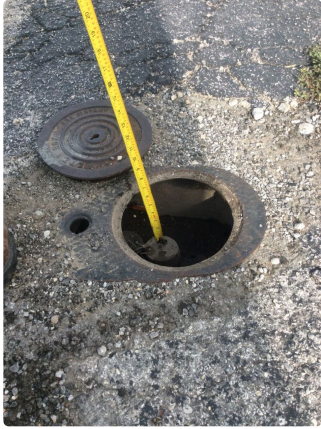
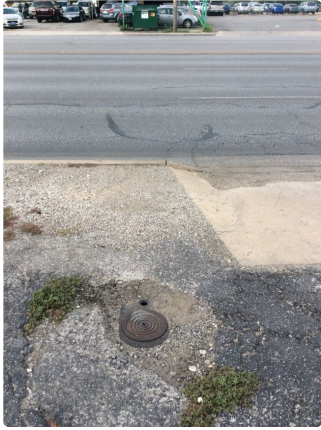
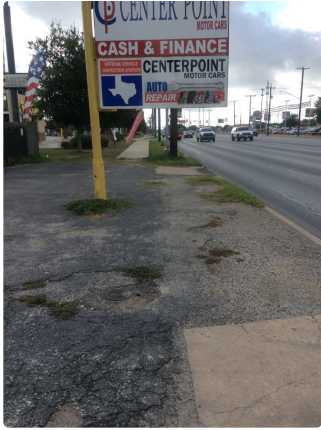
Size and Material	STANDARD WATER METER, CAST IRON				
	Accessible Route	ASSET IS OUTSIDE ACCESSIBLE ROUTE				
	Longitudinal or Crossing	CROSSING				
	Placement Relative to ROW	INSIDE ROW				
LOCATION	Sheet No.	188

Station	790+20.89				
	Offset	-21.9772				
	Latitude	+29.357568				
	Longitude	-98.55087				
SUE	Level of Investigation Req'd	NONE				
	Test Hole No	N/A				
	Test Hole Depth	N/A				
RESOLUTION	Recommended Action	MINIMIZE - PROTECT IN PLACE

Estimated Resolution Date					
	Resolution Status	UTILITY OWNER INFORMED OF UTILITY				
	Comment	Top of meter to surface = 4" Back of curb to meter = 8'-4"				
Date Collected		8/6/2018 9:16:34 AM		Date Modified	12/18/2018 7:22:52 AM
