Utility Conflict Report

OWNER	Utility	CPS	Corridor	NOGALITOS	SITE PHOTOS		
	Contact	JAKE MARTINEZ	ID	3062			
GENERAL INFO	Utility	ELECTRIC

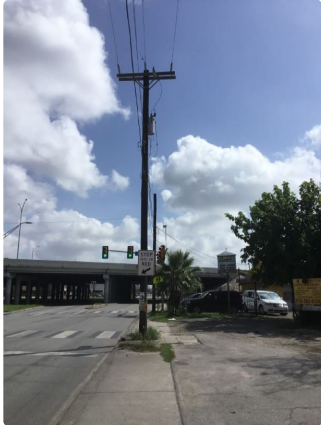
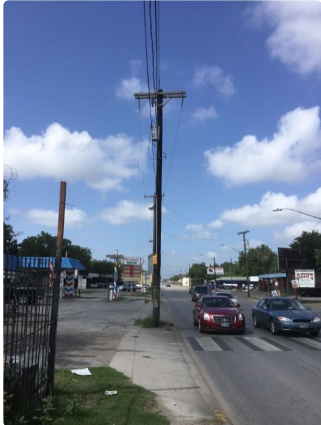
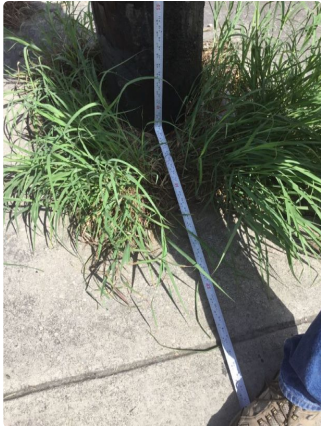
Size and Material	STANDARD POWER POLE, TIMBER					
	Accessible Route	ASSET IS INSIDE ACCESSIBLE ROUTE					
	Longitudinal or Crossing	CROSSING					
	Placement Relative to ROW	INSIDE ROW					
LOCATION	Sheet No.	90

Comment	Pole to back of sidewalk = 3'-9" Pole to back of curb = 1'-8" Sidewalk width (at pole) = 6'-6" Sidewalk width (typical) = 4'-10"					
Date Collected		7/11/2018 10:42:37 AM		Date Modified		9/13/2018 2:01:21 PM

Test Hole No	N/A					
	Test Hole Depth	N/A					
RESOLUTION	Recommended Action	MINIMIZE - PROTECT IN PLACE					
	Estimated Resolution Date						
	Resolution Status	UTILITY OWNER INFORMED OF UTILITY
