Utility Conflict Report

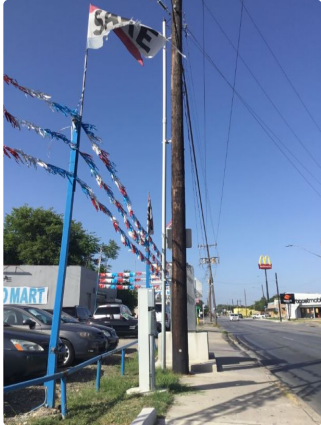
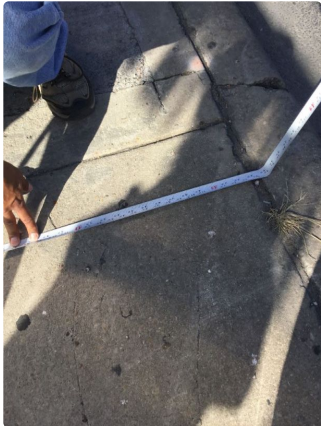
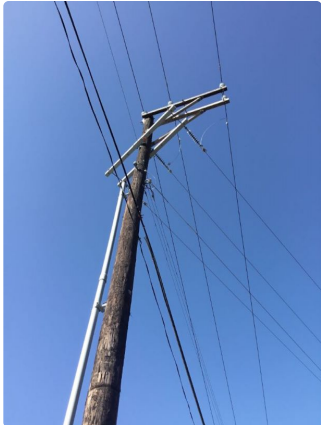
OWNER	Utility	CPS	Corridor	NOGALITOS	SITE PHOTOS		
	Contact	JAKE MARTINEZ	ID	4006			
GENERAL INFO	Utility	ELECTRIC					
	Size and Material	STANDARD POWER POLE, TIMBER					
	Accessible Route	ASSET IS INSIDE ACCESSIBLE ROUTE					
	Longitudinal or Crossing	CROSSING					
	Placement Relative to ROW	INSIDE ROW					
LOCATION	Sheet No.						
	Station	104+20.04					
	Offset	27.8541					
	Latitude	+29.386979					
	Longitude	-98.52329					
SUE	Level of Investigation Req'd	NONE					
	Test Hole No	N/A					
	Test Hole Depth	N/A					
RESOLUTION	Recommended Action	NO CONFLICT					
	Estimated Resolution Date	8/13/2018					
	Resolution Status	NO RESOLUTION WAS REQUIRED

Comment	Pole ID: 449403					
		Back of curb to traffic signal foundation = 3'-6" Pole to traffic signal foundation = 1'-0" Pole to back of curb = 5'-4" Pole to fence = 3'-0"					
Date Collected		7/2/2018 9:20:54 AM		Date Modified		8/14/2018 4:38:26 PM
