Utility Conflict Report

OWNER	Utility	SAWS	Corridor	NOGALITOS	SITE PHOTOS	
	Contact	ANN PECHE	ID	4074		
GENERAL INFO	Utility	WATER

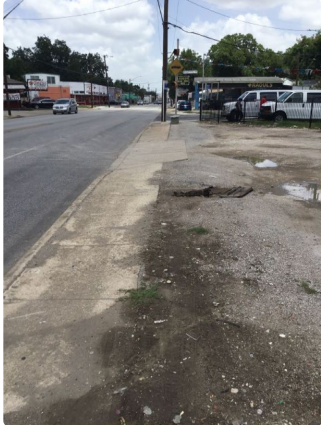
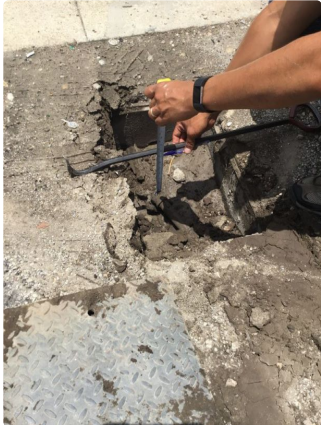
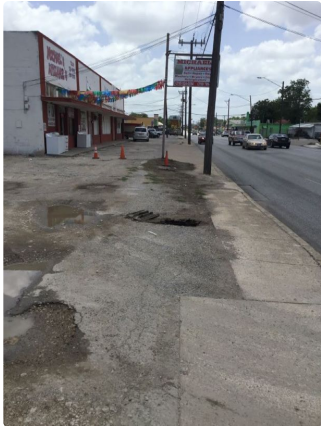
Size and Material	STANDARD WATER METER, STEEL				
	Accessible Route	ASSET IS OUTSIDE ACCESSIBLE ROUTE				
	Longitudinal or Crossing	CROSSING				
	Placement Relative to ROW	INSIDE ROW				
LOCATION	Sheet No.	80

Test Hole No	N/A				
	Test Hole Depth	N/A				
RESOLUTION	Recommended Action	NO CONFLICT				
	Estimated Resolution Date					
	Resolution Status	NO RESOLUTION WAS REQUIRED				
	Comment	Top of pipe to surface = 7 1/2" Meter to back of sidewalk = 11" Steel plate lid thickness = 1/2" Lid not labeled				
Date Collected		7/10/2018 1:52:21 PM		Date Modified	8/15/2018 12:45:54 PM
