# CITY OF SAN MARCOS ADA TRANSITION PLAN SIGNALIZED INTERSECTION ASSESSMENT AND COMPLIANCE REPORT

Location ID: 0000000201  
 North-South Cross Street: LEAH  
 East-West Cross Street: WONDER WORLD

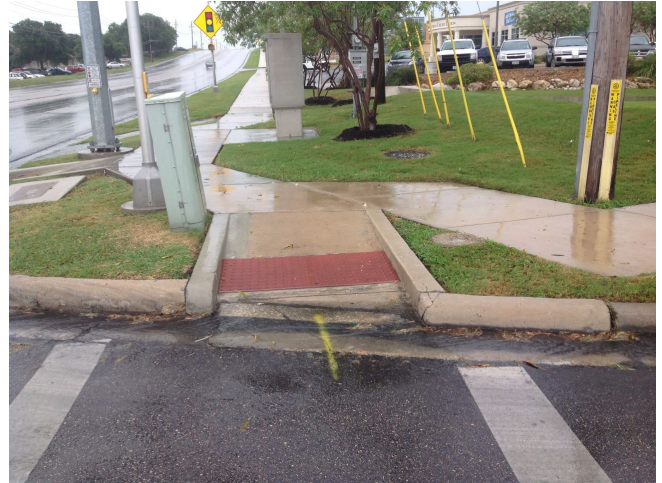
<b>Ramp Elements</b>	Curb ramp provided where an accessible route crosses a barrier:	YES
	Is the slope of the ramp 1:12 or less:	NO
	Transition from curb ramp slope to roadway free from abrupt changes, no greater than 1:20:	NO
	Ramp is at least 36" wide:	YES
	Ramp surface is stable, firm, and slip resistant:	YES
<b>Flare</b>	Flares (if present) are 1:10 or less measured along the curb line; or If landing at top of ramp is not provided flares are 1:12 or less:	N/A
<b>Detectable Warning Surface</b>	Curb ramp is located such that it does not project into roadway or parking aisles:	N/A
	Detectable warning is present:	YES
	DWS maintains correct geometric controls; 0.9" diameter domes, 0.2" in height, spaced at 2.35" and visually contrasts adjacent ramp surface:	YES
<b>Special Ramps</b>	Ramp maintains defined edges parallel to direction of pedestrian travel; maintains 4'x4' turning pad contained in crosswalk; flared sides 24" segment on each side of ramp within crosswalk lines:	N/A

Ramp is located so they will not be obstructed by parked vehicles:	N/A
	Ramp wholly contained within the crosswalk lines:	YES
	If island is present; Island maintains a cut through at street level or ramps on either side with landing between them:	N/A
