## Utility Conflict Report

<b>OWNER</b>	<b>Utility</b>	SAWS	<b>Corridor</b>	SW MILITARY	<b>SITE PHOTOS</b>	
	<b>Contact</b>	ANN PECHE	<b>ID</b>	3165		
<b>GENERAL INFO</b>	<b>Utility</b>	WATER

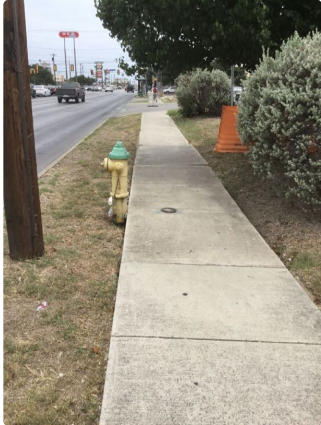
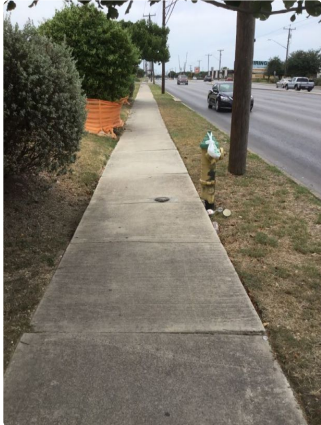
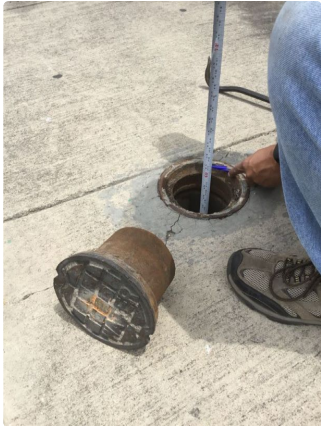
<b>Size and Material</b>	STANDARD WATER VALVE, CAST IRON				
	<b>Accessible Route</b>	ASSET IS INSIDE ACCESSIBLE ROUTE				
	<b>Longitudinal or Crossing</b>	CROSSING				
	<b>Placement Relative to ROW</b>	INSIDE ROW				
<b>LOCATION</b>	<b>Sheet No.</b>	146

<b>Test Hole No</b>	N/A				
	<b>Test Hole Depth</b>	N/A				
<b>RESOLUTION</b>	<b>Recommended Action</b>	NO CONFLICT				
	<b>Estimated Resolution Date</b>					
	<b>Resolution Status</b>	NO RESOLUTION WAS REQUIRED				
	<b>Comment</b>	Top of valve to surface = 6'-1" Lid thickness = 1 1/8" Valve to back of sidewalk = 2'-10 1/2" Sidewalk width = 5'-0"
